Commissioning of crab cavity system

Presented by NAKANISHI Kota (KEK)

Factories08@BINP 2008/4/15

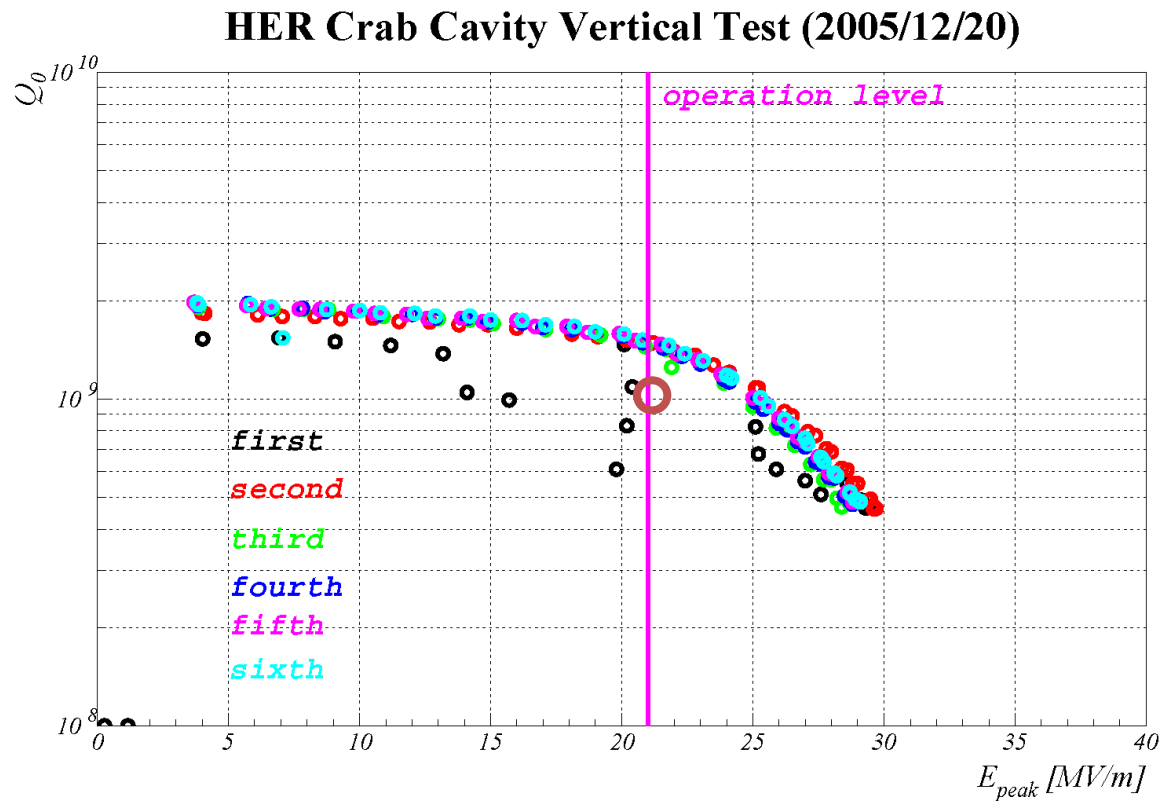
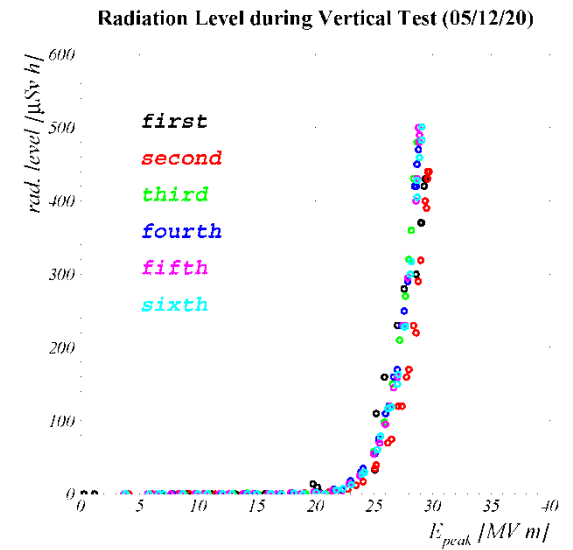
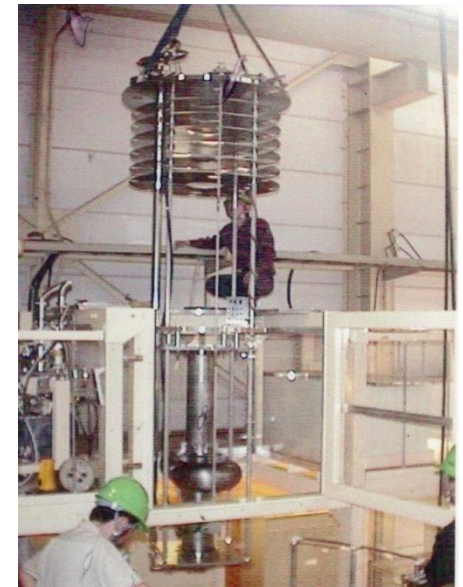
Test Result Crab Cavity for HER

21MV/m (E_{peak}) = 1.4MV (Kick voltage)

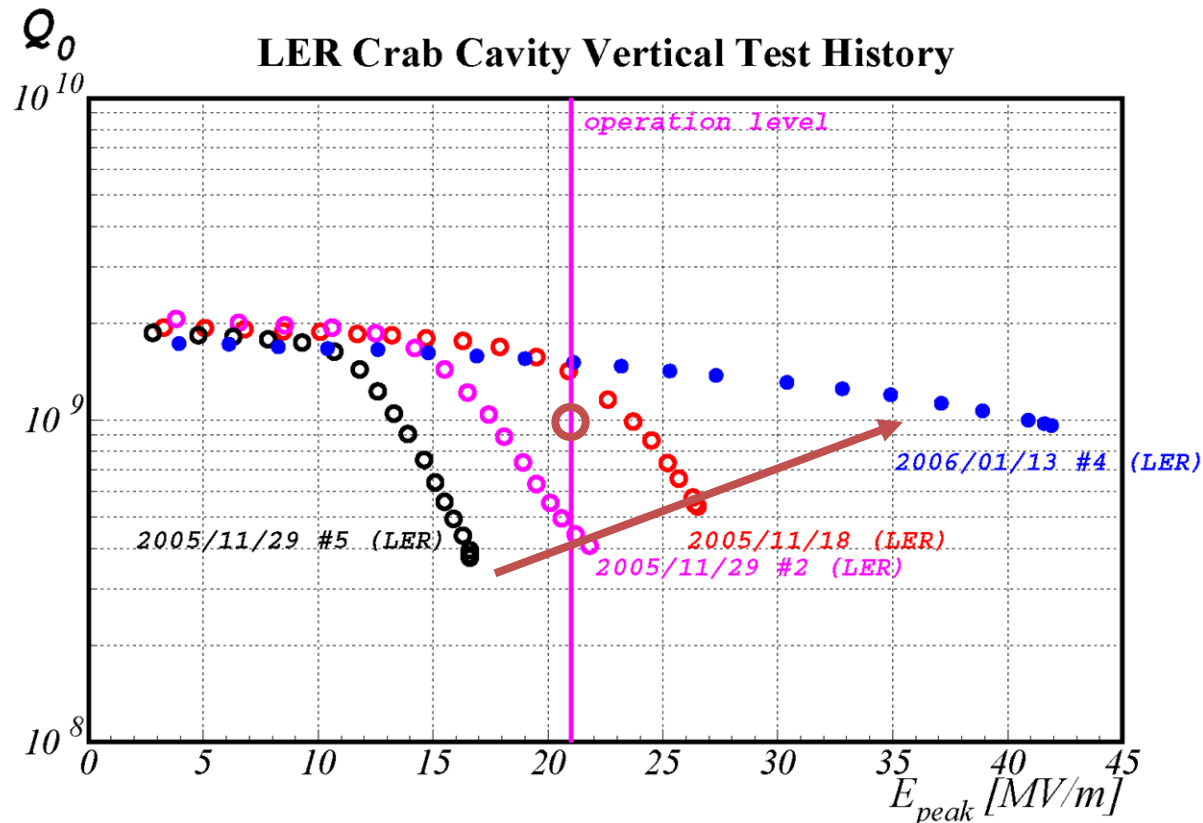
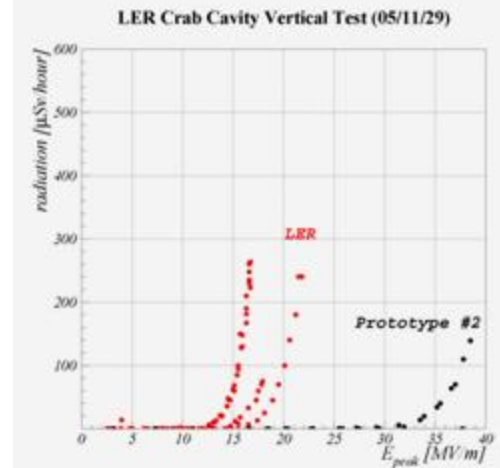
Test Result Crab Cavity for LER

X-Ray

Nov. 18 1st Test

Nov. 29 2nd Test

Field Emission

Jan. 13 Test

Recovered !
