SIX MONTHS OF OPERATION OF THE NEW RF CAVITY SYSTEM OF SLRI

N. Juntong[†], Ch. Dhammatong, P. Sudmuang, N. Suradet
Synchrotron Light Research Institute, Nakhon Ratchasima, Thailand

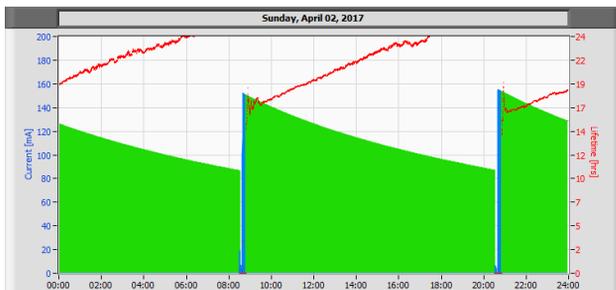
Figure 1: Beam current during the 24 hours beam service period of SLRI.

The SPS services beam is in a decay mode with a maximum 150 mA electron beam at 1.2 GeV. Electron is first injected with the beam energy of 1.0 GeV from the booster ring and later ramped up to 1.2 GeV. The service is 11.5 hours per shift with 1 hour reserved for injections. The 24 hours beam current is illustrated in Fig. 1 and can be seen real-time online at the machine status webpage [4].

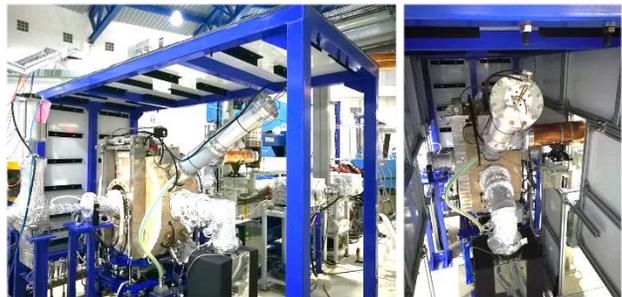
Figure 2: The RF cavity in the local shielding.

The new RF cavity was conditioned after it has been installed in the storage ring. The SPS storage ring has no shielding roof. A radiation has been detected higher than a safety standard in the experimental hall during a conditioning process. Unauthorised person was not allowed entering an experimental hall during the conditioning. The cavity was later shielded locally as shown in Fig. 2 and the operation with electron beam has been monitored within a safety radiation level.

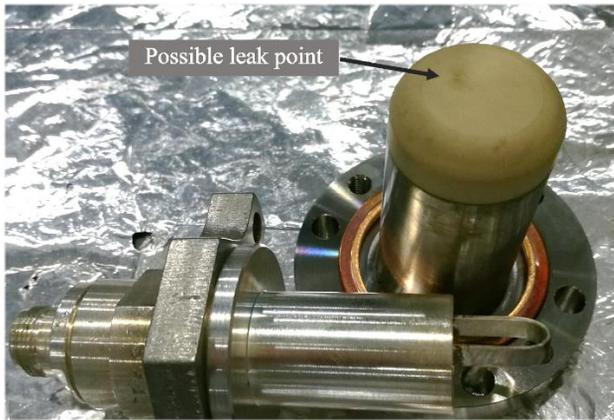
Figure 3: The possible leak point of the pickup probe ceramic window.

The RF cavity was diagnosed with a minor leak after the acceptance test process, running at 30 kW RF power for 12 hours. The leak was observed after changing the beta coupling from 1 to 2 as the base pressure of the section could not reach 10^{-10} Torr after the vacuum baking process. The leak position was found at one of the pickup probe ceramic window as shown in Fig. 3. The leakage might caused by either a fast RF conditioning process or the impurity in the ceramic window during a manufacturing. There might be a tiny spark on the ceramic surface when electric field was concentrated on that surface. The leaked window was replaced by a blind flange as there was no spare window. The other pickup probe was used for monitoring the RF accelerating voltage and phase.

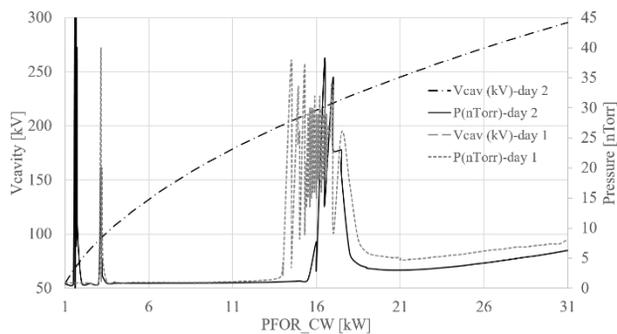
Figure 4: Results of the December conditioning.

The December conditioning was scheduled for two nights. Main activity was to push the cavity to its limit at 30 kW power. The vacuum pressure and the cavity voltage with various RF power during the conditioning is shown in Fig. 4. The cavity voltage increased with respect to the input power, but it was not 300 kV at 30 kW power. It was 295 kV. The voltage will reach 300kV when a good vacuum has been obtained inside a cavity. The multipacting was observed from an unexpected increasing of the vacuum. They were at 3.1-3.2 kW and 13.9-18.0 kW. The range at a higher power was narrowed down to 16-17.5 kW

after the first night of treatment. The amplitude of multipacting at 3.2 kW was decreased, but there was a high multipacting at 1.7 kW as can be seen in Fig. 4. The low power multipacting can be allowed as the operational point is not at a low power, but the high power multipacting shouldn't be avoided. It will limit the smooth variation of the cavity voltage. The treatment of these high power multipacting was resumed in the February conditioning.

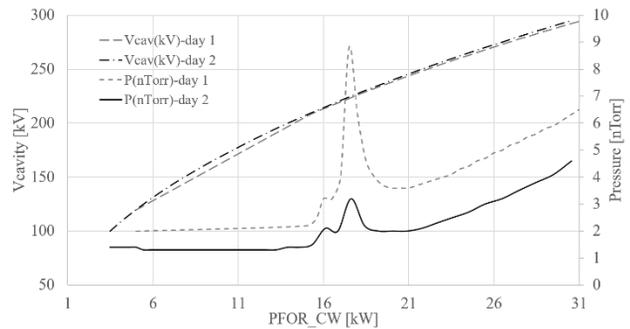
Figure 5: Results of the February conditioning.

The February conditioning was also scheduled for two nights. Main activity is to cure a high power multipacting. The pressure and the cavity voltage resulting from this conditioning is shown in Fig. 5. Comparing with the December conditioning, the multipacting magnitude is much lower. The multipacting was at 16-18kW and at the low power of 1.7kW and 3.3kW. The amplitude of pressure was decreased after the treatment especially for the high-power points. The conditioning will resume in the next scheduled slot.

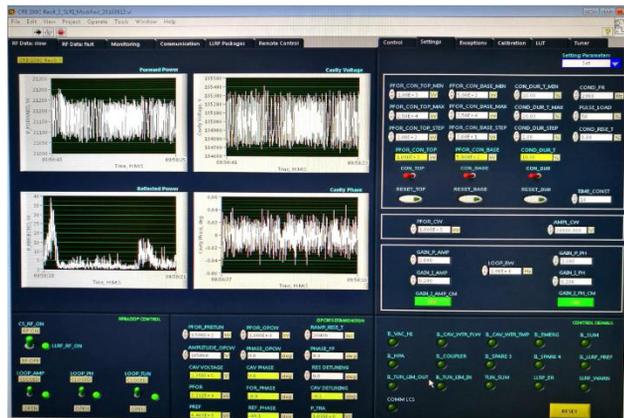
Figure 6: The new RF system control panel.

The new RF system is running as the main system while the existing system is kept as the backup. The cavity was operated at 185 kV for storing electron beam 150 mA at 1.2 GeV. This operating parameter is sufficiency for a beam lifetime and the radiation is within the safety limit. The control panel of the RF system is shown in Fig. 6. This control screen can be accessed either from a control room or at the LLRF control rack. The cavity voltage and phase

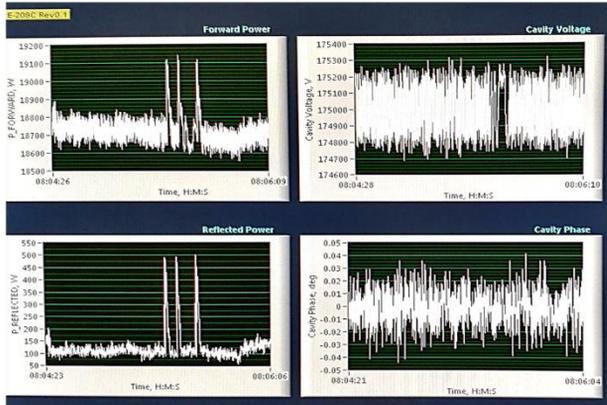
Figure 7: The reflection during a frequency adjusting.

is well controlled within ± 500 V and ± 0.1 degree, respectively. There was a reflection when changing the master oscillator frequency during a machine parameters measurement as shown in Fig. 7. The reflection is caused by the frequency mismatch between cavity and amplifier, but this mismatch can be solved by the tuner mechanism of the cavity.

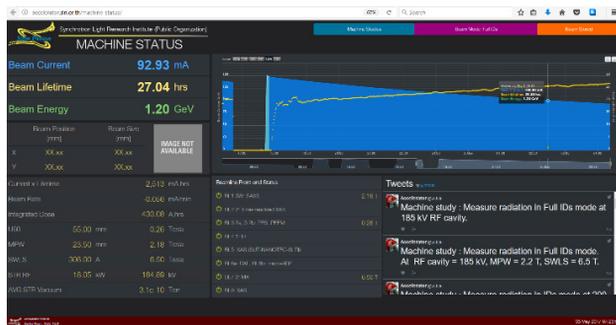
Figure 8: Operational status of the SPS storage ring.

There were no serious failure effects to user beam time from the new RF system during a six-months operation. The beam lifetime in mode 4 and mode 5 at 185 kV cavity voltage is greater than 20 hours. The machine status and important parameters as shown in Fig. 8 can be seen online via the machine status website. The operational history and the electronic logbook can also be accessed online.

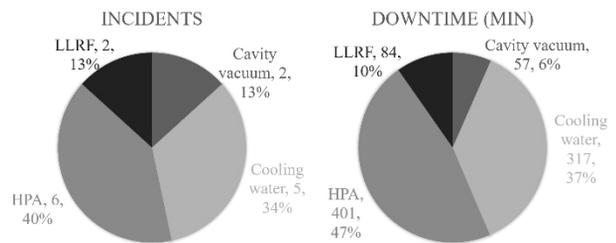
Figure 9: The new RF system breakdown issues.

The downtime of the new RF system during the six-months period can be categorised by a sub-system failure as illustrated in Fig. 9. The high downtime during this period was from a learning curved of the maintenance. The failure in the high-power RF amplifier (HPA) system was the major downtime of the RF system followed by the failure in water cooling system. The HPA system failure was mainly from the controller communication fault. The communication problem was solved by replacing a flash card of the PLC, which contain a new programming algorithm.

The cooling system problem was mainly from the cavity cooling flow rate dropped. This was caused by the heat accumulated in the cooling unit and degraded the compressor

performance. After the heat issue has been rectified, the problem was solved. The HPA cooling system had one of three compressors overloaded. This problem is being investigated with a manufacturer.

There were a vacuum incidents from the cavity section. This is the usual phenomenon of the new RF cavity. After the base pressure inside the cavity is getting better, the residual gas captured beneath the cavity inner surface will burst out and this make a pressure inside the cavity increase suddenly. The problem will disappear after a long operation of the cavity. The LLRF system problem was mainly from an error of the controlling program. This was actioned by restarting the system.
