# Accelerator Vacuum Windows: A Review of Past Research and a Strategy for the Development of a New Design for Improved Safety and Longevity for Particle Accelerators

Christine Ader, IPAC 2019

FERMILAB-SLIDES-19-038-AD

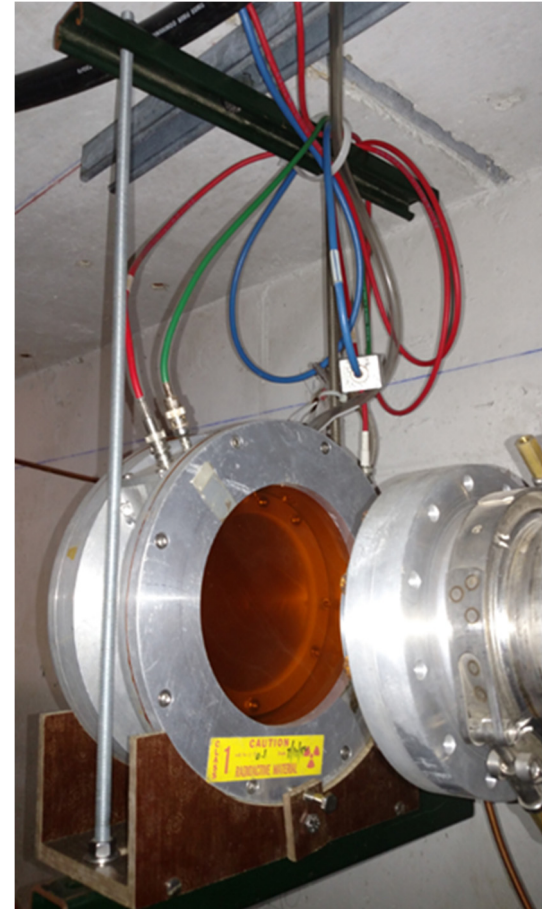
- Vacuum windows: thin separation between a volume under vacuum and a volume at atmospheric pressure or vacuum and through which primary or secondary beam passes.
- Vacuum window is any thin material that isolates volumes of beam tube.
- There are approximately 83 vacuum windows in operation at Fermilab, 5 made of beryllium.
- Photo shows a Switchyard ion chamber and an upstream vacuum window
