National Synchrotron Light Source II

Experience of the first six years operations and plan in NSLS-II

*Guimei Wang for the NSLS-II team
National Synchrotron Light Source II
Brookhaven National Lab
IPAC21, May 24-28, 2021, Campinas, Brazil*

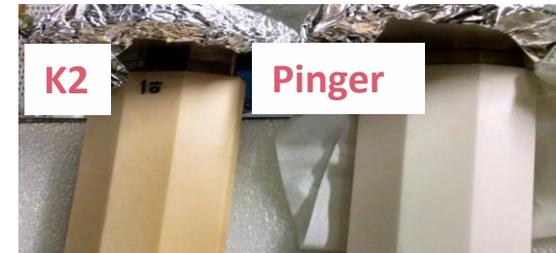
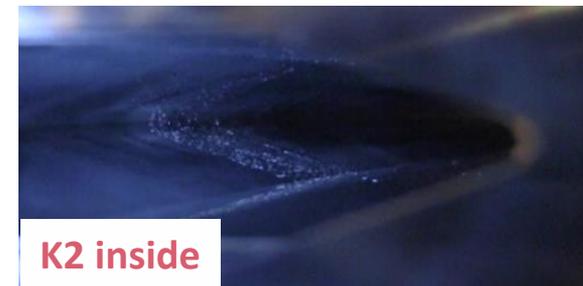
Damaged Kicker 2 chamber

- Observed heating and vacuum activity during first high current studies in Feb. 2016
- Kicker chamber 2 reached $> 100^\circ\text{C}$ @ 400mA. Discovered Titanium coating flaked off and chamber discolored
- Due to limited space, RTDs were installed at the end of chambers to monitor temperature
- High uneven localized heating or abrupt temperature changes
- Chamber failure can cause two days downtime

- Replaced damaged kicker chamber
- Installed cooling system
- Replaced RF springs between flanges and bellows
- Installed IR camera to monitor heat distribution
- Procured 5 new ceramic chambers and applied Titanium coating in-house. Installed three chambers in May. 2017-Sep. 2018
- Ceramic Temperature reduced to ~ 40 °C @400 mA

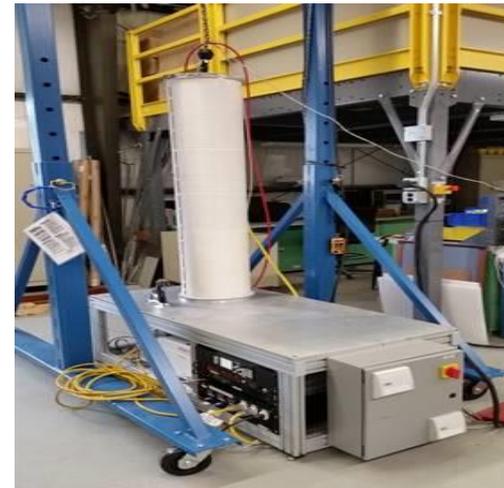
2019: Ceramic chamber temp.

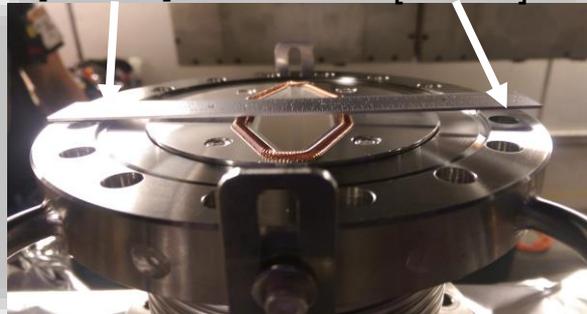
Improper installation of RF springs

[0.4mm] [2.2mm]

- Certain temp. sensors indicated temperature $> 80^{\circ}\text{C}$
- Improper RF spring installation caused trapped mode heating
- Temp. sensors installed at discrete locations do not show all hot spots

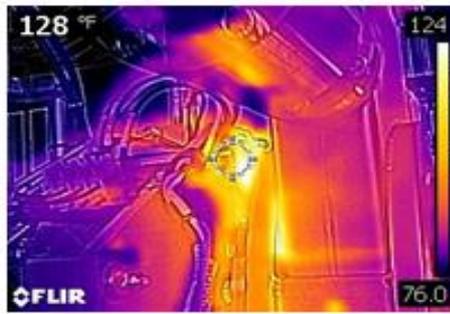
C16 temp. with IR camera

- In-situ thermal survey: discovered that majority of heated flanges were located at straight sections
- Installed IR cameras to monitor heat distribution
- Developed new RF spring installation procedure
- Replaced 39 RF springs since 2017 to reduce heating
- Install 770 1-wire sensors at flanges
