LIFETIME TESTING 700 MHZ RF WINDOWS FOR THE ACCELERATOR PRODUCTION OF TRITIUM PROGRAM

K. A. Cummings, M. D. Borrego, J. DeBaca, J. S. Harrison, M. B. Rodriguez, D. M. Roybal, W. T. Roybal, S. C. Ruggles, P. A. Torrez, LANL, Los Alamos, NM 87545, USA
G. D. White, Marconi Applied Technologies, Chelmsford, England

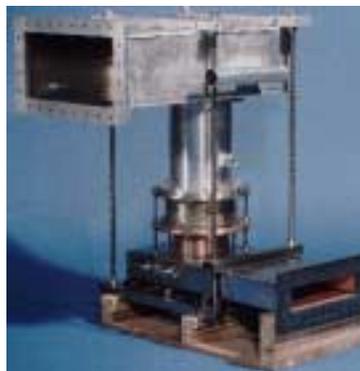
The windows are a coaxial geometry using an AL995 alumina ceramic. As shown in Figure 1, the window assembly consists of half height WR 1150 waveguide on the vacuum side, a T-Bar transition into the coaxial region of the alumina ceramic, and another T-Bar to transition to full height WR 1500 waveguide on the air side. The configuration shown in Figure 1 is referred to as a right handed configuration. The air side waveguide may be rotated 180 degrees around the axis of the coax to yield a

Figure 1: EEV 700 MHz RF Window.

left handed configuration. Both the right handed and the left handed configurations are used to feed power to the Coupled Cavity Drift Tube Linac (CCDTL) on the APT accelerator. The vacuum side waveguide is copper plated stainless steel. The inner and outer coax is copper and the air side waveguide is aluminum.

The windows are cooled with 40 CFM of air cooling and 2 GPM of water cooling. The air inlet is at the air side T bar. The air flows through the T bar on the air side, down the inner conductor, and then exits the inner conductor through a series of exit holes and flows across the alumina ceramic. The air exits the coaxial region through a series of exit holes on the outer conductor and is vented to the ambient environment. The water circuit cools the vacuum side T bar region and the vacuum waveguide.

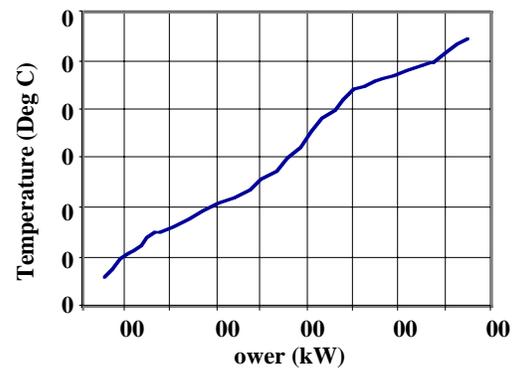
Figure 2: Steady State Temperature vs. Power.

The steady state temperature of the outer coaxial surface at various power levels are shown in Figure 2. The temperatures shown are from windows that did not show any arcing, glowing or heating problems. During the high power acceptance testing the outer coaxial surface temperatures of the windows are compared to this data as a tool to indicate any problems.

The variations in the coaxial surface temperature, air outlet temperature, amount of arcing, and vacuum pressure are examined over time. As shown in Figure 3, the coaxial surface temperature is plotted at various power levels during each month for serial numbers 12 and 13. As expected from Figure 2, the average temperature increases with the average power, however, there is no correlation of temperature, either increasing or decreasing, with time. Figure 4 shows no correlation between the air outlet temperature and test time; however, the noticeable increase in the air out temperature with power can be easily seen. The vacuum pressure remained very constant throughout the testing and there were no significant number of arcs.

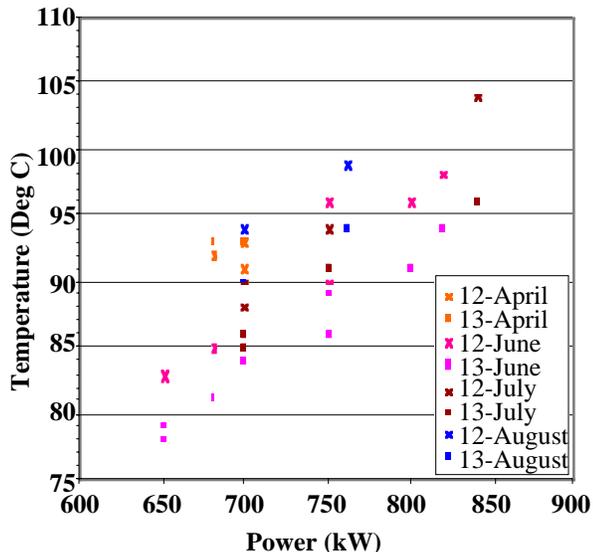
Figure 3: Average Coaxial Surface Temperatures.

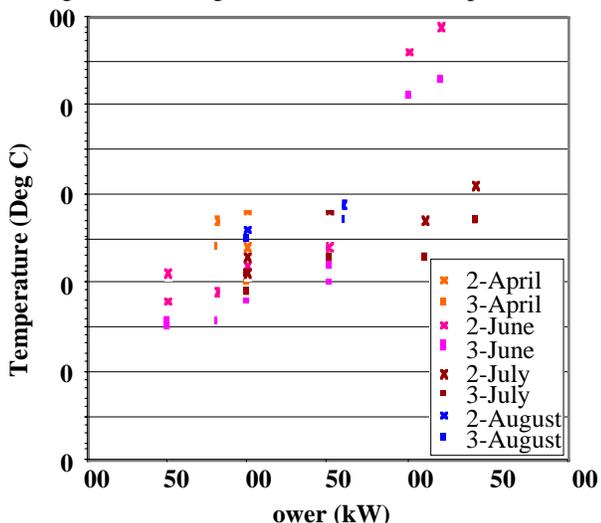
Figure 4: Average Air Out Temperatures.
