THE NEW 500 keV SINGLE-GAP PRE-INJECTOR TUBE
FOR THE CERN PROTON SYNCHROTRON LINAC

J. Huguenin, R. Dubois, G. Visconti, R. El-Bez
European Organization for Nuclear Research
Geneva, Switzerland

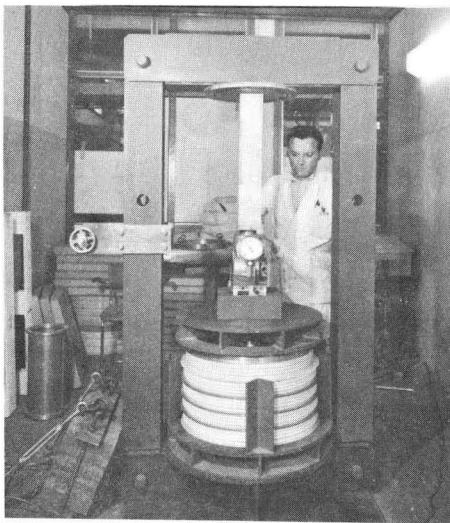
Fig. 8b. Same as Fig. 8a, but with load of 15 tons applied.

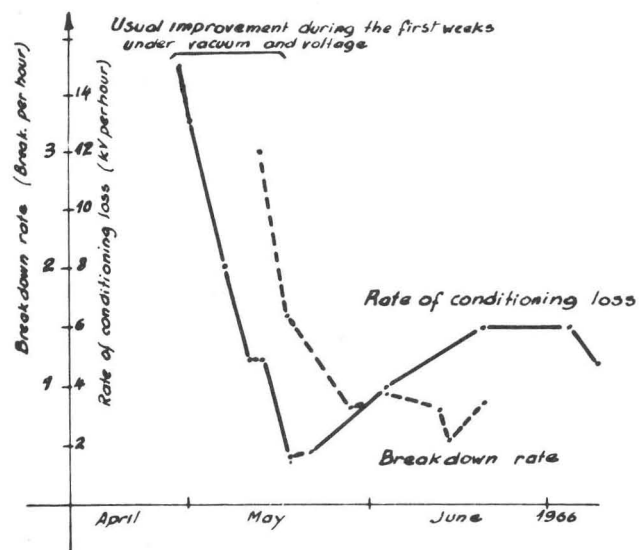
Fig. 13. Breakdown rate and rate of conditioning loss since April 1966.

In April 1966, during the three-month shutdown of the proton synchrotron, the new pre-injector was re-installed in the Linac, taking great care to have a close control of the situation, adding step by step each new element in the system and checking the hold-off after every change. Residual gas analysis was first made, but did not show anything abnormal. The section between pre-injector tank and Linac Tank I had been dismounted, cleaned and remounted grease-free, or with only a minimum of grease. All insulation material in tank A had been protected by a metal screen against ionic, electronic or beam proton bombardment. Excellent results were obtained in this manner. Only the 550 keV beam stopper was left in pyrex and caused trouble during the time necessary to degas it under beam bombardment. Deconditioning rates, starting at ~ 12 kV/h at the first formation, went down in three weeks to the very low figure of 1 kV/h, this improvement being produced by time and voltage. Simultaneously, breakdown rates went down correspondingly. On 15 July, as this report is being written, the tube has been working two months continuously on operational regime at 540 kV. Fig. 13 shows the evolution of breakdown rates and deconditioning since April 1966. Let us mention that the cathode current being so low (1 - 5 μ A peak in microdischarges), the mean X-ray dose is about 1 mR at 4 metres.
