# ANALYSIS AND RESULTS OF THE INDUSTRIAL PRODUCTION OF THE SUPERCONDUCTING Nb/Cu CAVITIES FOR THE LEP 2 PROJECT

E. Chiaveri, C. Benvenuti, R. Cosso, D. Lacarrere, K.M. Schirm, M. Taufer, W. Weingarten  
CERN, 1211 Geneva 23, Switzerland

For the energy upgrade of the Large Electron Positron Collider at CERN, 216 RF superconducting cavities were ordered from three European industrial firms (Ansaldo, Cerca, Siemens/Accel) at the beginning of 1991. These cavities are made of copper (Cu), internally coated with niobium (Nb) according to a procedure developed at CERN. Up to now about 147 of these cavities fulfilling the specifications have been produced. The large-scale statistics available and the use of dedicated analytical and optical inspection techniques shed new light on the relationship between production procedures, niobium film properties and cavity performance. An overview of this subject is presented, together with some significant trends and results.

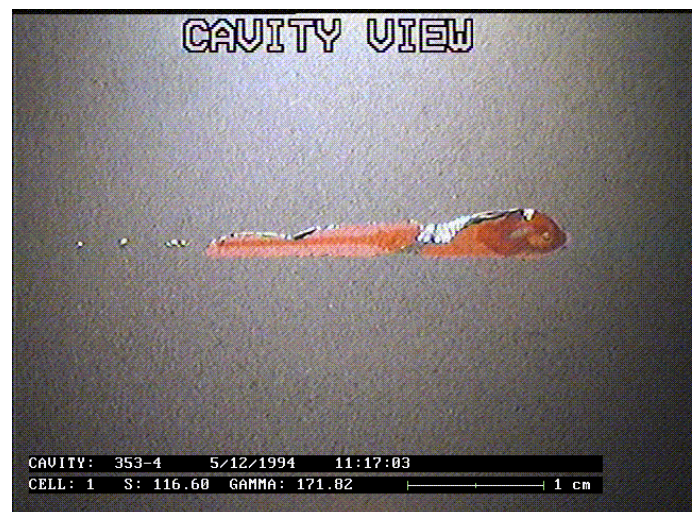
Fig.1: Major defect on the inner cavity surface (~2 cm).

The cavity performance is sometimes limited by local defects (up to several mm in size) of the Nb layer. Major defects like poor bonding (blister) of small Nb areas (Fig. 1) are usually detected as "hot spots" in the temperature maps [2] of RF tests. Investigations of such defective layers by optical [3] and surface analytical tools [4,5] have been launched in order to clarify the nature and origin of various types of defect and also of other minor irregularities that can occur in considerable numbers without being detected in temperature maps. After inspection, these cavities must have the defective Nb layer chemically removed at CERN and are then returned to the manufacturer for a second or even a third Nb coating.

Cavities that are rejected after the RF measurements are systematically investigated by means of a video camera set-up on a computer controlled optical inspection bench [3]. Pictures of surface defects and irregularities (fig.1 and 2) are taken at different magnification together with the position coordinates.

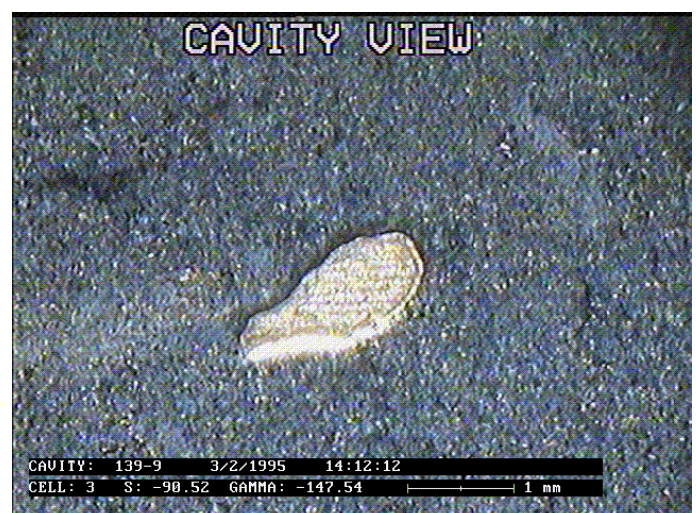
Fig.2: Inner cavity surface with 1.5 mm long irregularity.

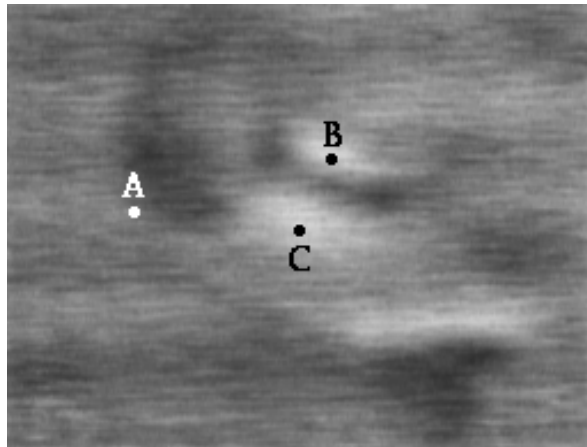
Fig.3a: Secondary electron image

In figure 3 an example of characterization of a defective area is shown. A Secondary Electron Image of the defective area (3a), its associated O elemental map (3b), and related Auger electron spectra (3c) are presented. Since the surface of the film consists of Nb oxidised mainly in the form  $Nb_2O_5$  [6], corresponding to an atomic concentration of oxygen  $X_O \approx 0.7$ , it can be concluded that the light area in fig. 3b corresponds to a region where the Nb film is present and the dark area to a region where it is either very thin or missing. The black spot at the bottom of the picture corresponds to the highest concentration observed in this area. This conclusion is supported by the Auger spectra shown in 3c, corresponding to points A, B and C in the SED image (3a). In spectrum A no signal from the substrate is detected, whilst in B the copper 'fingerprint' is clearly visible; in C, copper is still present but the main contribution to the spectrum is given by the carbon line.

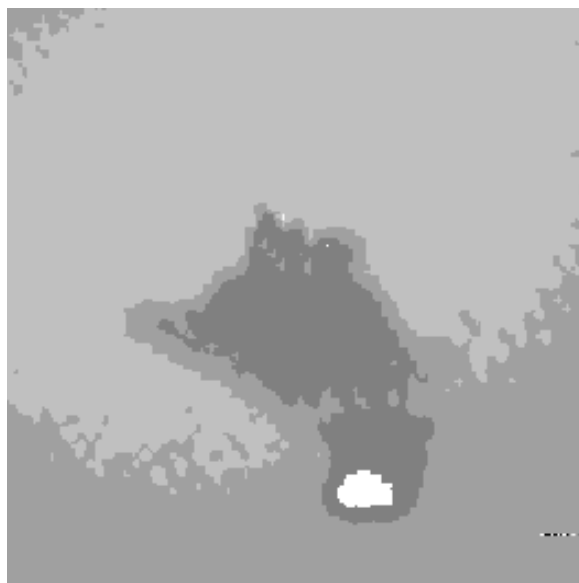
Fig.3b: Scanning Auger O map (darker areas correspond to lower concentration of O)

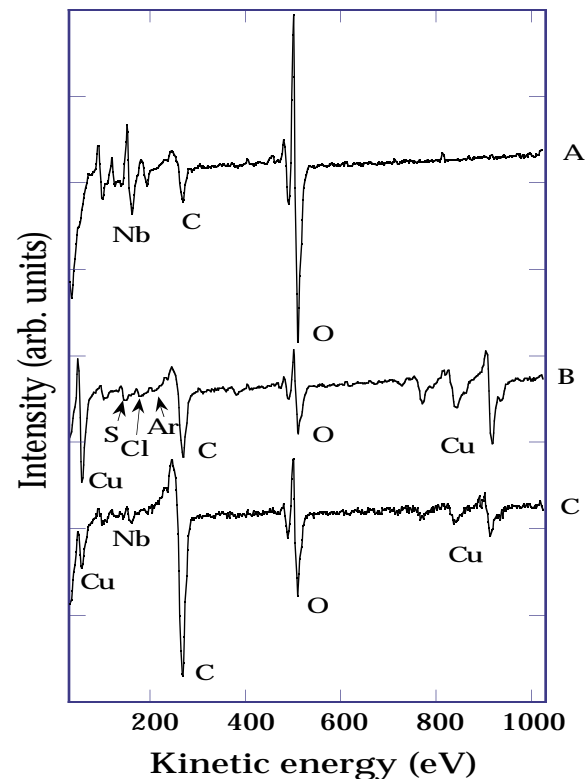
Fig.3c: Auger spectra taken at points A, B and C

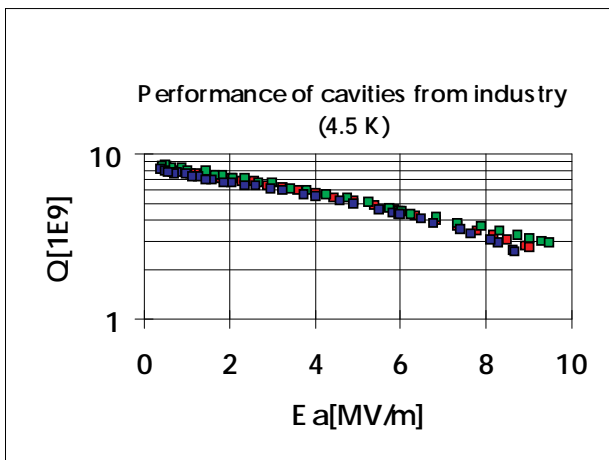
Fig.4: Recently obtained cavity performance for different manufacturers.

These parameters are interconnected since the bake-out protocol also determines the vacuum quality. Various possible incidents in the delicate manufacturing process preceding the coating can change the residual gas composition as indicated by mass spectrometry and the attainable pressure limit in the cavity (usually  $< 10^{-9}$  Torr). Consequences range from a decreased Q value at low field by the getter pumping effect of light gases during Nb deposit [1] to an insufficient Nb adhesion in presence of organic residues. The choice of the cavity temperatures for baking and sputtering determines not only the diffusion and outgassing rates but also the growth properties of the Nb layer and structural aspects of the copper substrate and their influence on its mechanical properties. In view of these partly conflicting aspects the best compromise appears to be the following: baking the cavities at 150°C for 24 h and coating them at cell temperatures strictly limited to  $\leq 200^\circ\text{C}$  (temperature maxima usually  $180^\circ\text{C} \pm 10^\circ\text{C}$ ). Respecting all the criteria mentioned above has resulted, at all three companies, in cavity performances well above the specification requirements (Fig.4) and considerably increased acceptance rates of cavities with only one Nb coating (Fig.5).

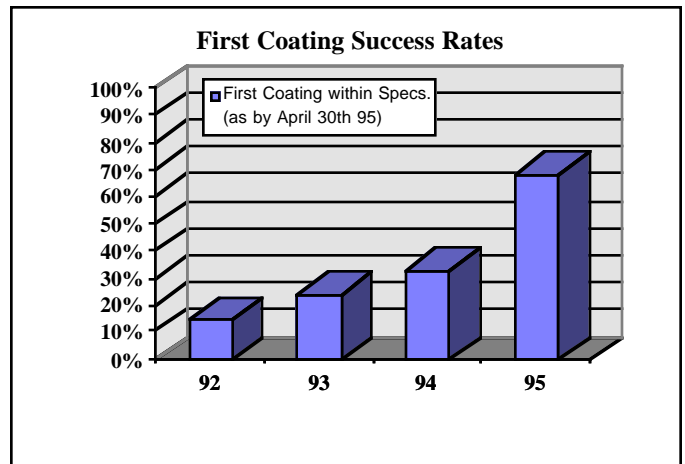
Fig.5: Total first coating success rates in industry
