UPDATE ON EP EXPERIENCES AT DESY WITH THE ELECTRO POLISHING PROCESS AT DESY 1.3 GHZ

M.Schmökel, A.Matheisen, B.Petersen, N.Steinhou-Kühl, H.Weitkämper DESY, Notkestraße 85, 22607 Hamburg, Germany

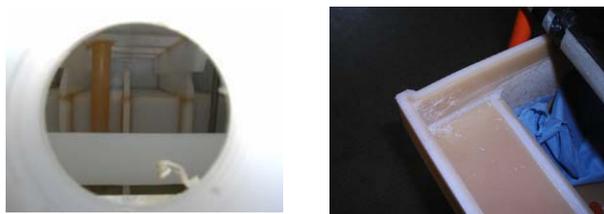
Figure 2: Left corrosion on welds of sump no 2; Right corrosion on the commercial available PVDF

Depending on the degree of polymerisation different resistance against aggressive media are reported. The sumps in use are made of commercial available plates by in house hot air welding. For sump No 2 high polymer PVDF was in use and showed corrosion in the welding seams which are exposed to different temperatures during welding. After two years about 40% of the wall, receptively weld thickness is corroded. This corrosion is observed even on areas with no direct contact to the acid. For safety reasons the sump tanks have to be exchanged at least every two years of contact with the acid or the evaporated gases.

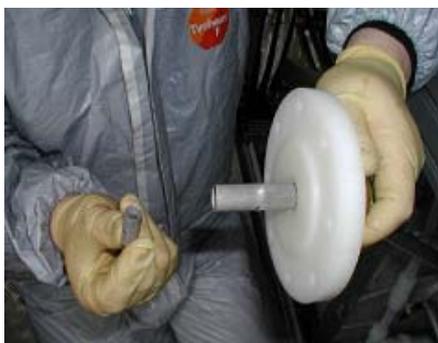
Figure 3: Impeller section detached form sensor due to corroded connectors

A flow sensor inside the acid supply line is part of the safety control and is one basic parameter out of three parameters in use to steer and control the process. It needed to be exchanged after 4 years of operation due to corrosion on the housing and the impeller (Fig.:3).
