HORIZONTAL TESTS FOR CRAB CAVITIES IN KEKB

Abstract

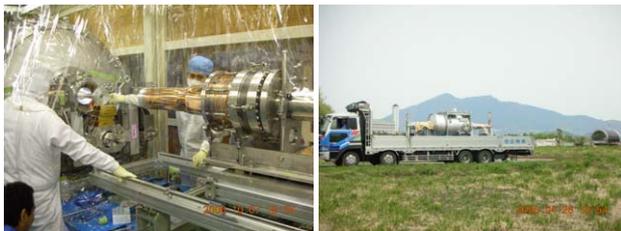
Figure 1: Photos of the assembly to the cryostat and the transfer to the horizontal test area.

The assembly of two Crab cavities was started from the beginning of 2006 [1, 2]. Figure 1 shows the situation of the assembly to the cryostat and the transfer to the horizontal test area. Figure 2 shows the assembly layout of HER Crab cavity. LER is designed in a mirror-symmetry for HER. HER Crab cavity was completed in April and the first horizontal test was carried out in May. The horizontal test is an overall test for a superconducting cavity before a tunnel installation without a beam. Although the kick voltage achieved 1.4MV, a tuner performance was not operated smoothly. It was necessary to improve it largely. The improvements were a large frequency stroke and a smoothed movement for the coaxial beam pipe. After these improvements, the horizontal tests were done for both cavities again. In this paper, these results are reported in detail and a recent status is described briefly.

It was very difficult to assemble the coaxial beam pipe to the cryostat at first. It is a very complicated component. The precision in the alignment is within 200 micro-meter. It takes a few days to assemble the coaxial beam pipe into the cryostat. After several months, the first assembly to the cryostat was successfully finished, because of an improved assembly jig.

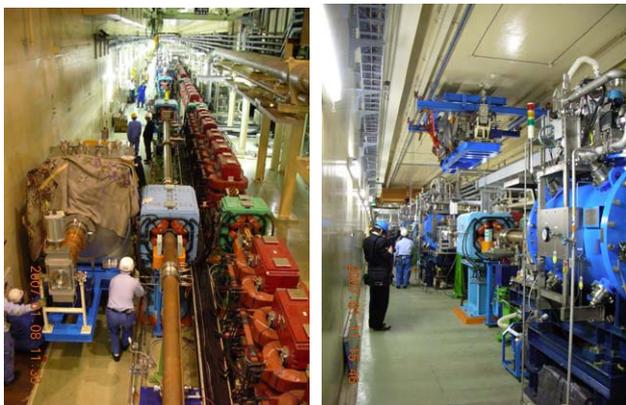
Figure 13: The photos during the tunnel installation.

After the horizontal tests, two Crab cavities were installed into the KEKB tunnel at the beginning of Jan in 2007. The tunnel installation was successfully finished. Figure 13 shows the situation for both cavities during the installation.
