# IDENTIFYING SPECIFIC CRYOMODULE AND CLEANROOM PARTICULATE CONTAMINATION: UNDERSTANDING LEGACY ISSUES AND PROVIDING NEW FEEDBACK STANDARDS\*

C.E. Reece<sup>†</sup>, J. Spradlin, O. Trofimova, and A-M. Valente-Feliciano  
Jefferson Lab, Newport News, VA, USA

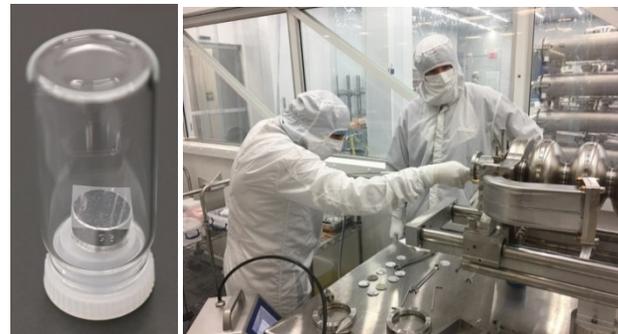
Figure 1: Standard sample spindle and example of particulate sampling from cavity interior.

Samples were collected under controlled conditions, and reference environmental samples were collected to help discriminate particulates derived from the intended sampled surface from particulates arriving to the analyzed spindle independently during the collection process (see Fig. 1).

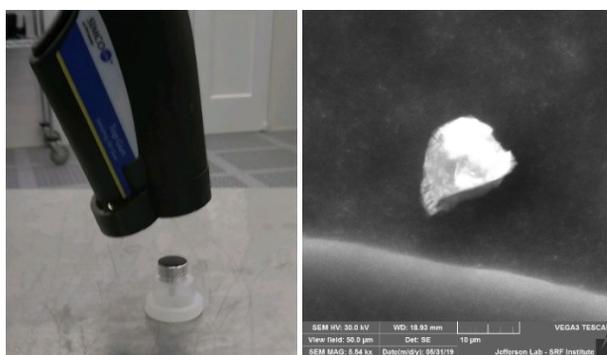
One simple exercise was to simply characterize the particulates emitted by the anti-static N<sub>2</sub> blow-off guns used routinely in the JLab cleanroom. A 1-minute, direct flow exposure on the carbon-tape capped sample, followed by five 1 sec bursts yielded on analysis 12 particulates 7–20 μm all having the same EDS spectrum dominated by silicon, with traces of Na, Mg, Al, K, Ca, Ti & Fe (Fig. 8). While investigation continues, we suspect the particulates may represent breakdown fragments of the point-of-use filter on the N<sub>2</sub> gun.

Figure 8: Particulate from N<sub>2</sub> gun test.
