# Identifying Specific Cryomodule and Cleanroom Particulate Contamination

Understanding Legacy Issues and Providing  
New Feedback Standards

Using a new automated particle detection and  
characterization system to examine samples

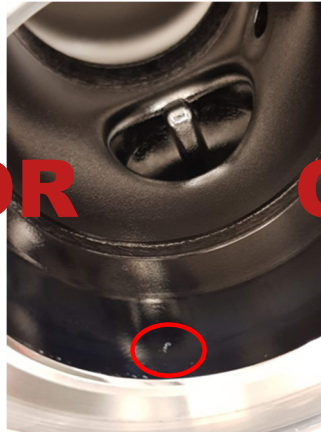
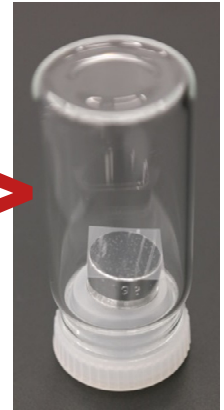
- We use commercially available **controlled clean samples**
  - Forensic gunshot residue (GSR) collection samples, 12 mm diameter
  - Certified clean carbon tape on serialized aluminum spindles
- Types of sample collection onto carbon tape:
  - swabbing, shaking of components, carbon tape contact & environmental witness

Swabbing

Shaking of Components

Carbon Tape Contact

Collection Witness

GSR Sample  
S####

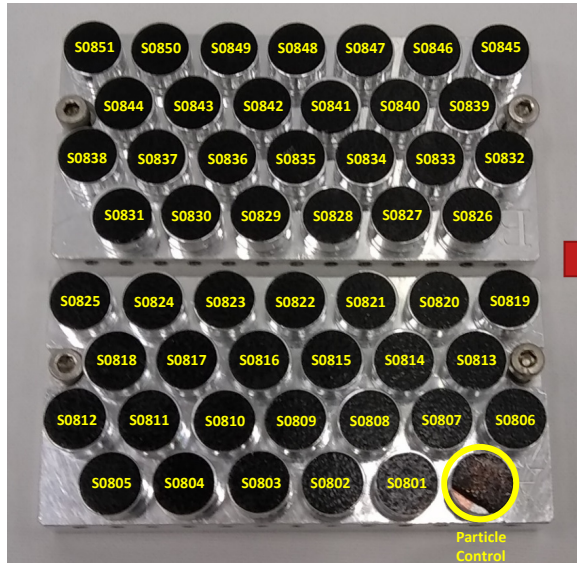
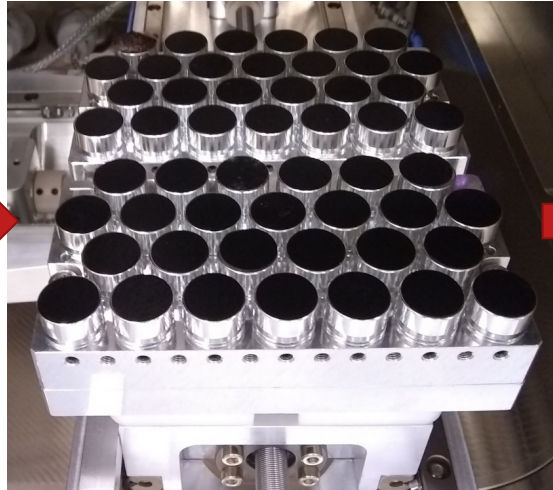
- System can process up to 51 GSR Samples & one Control Sample in single load of the SEM.

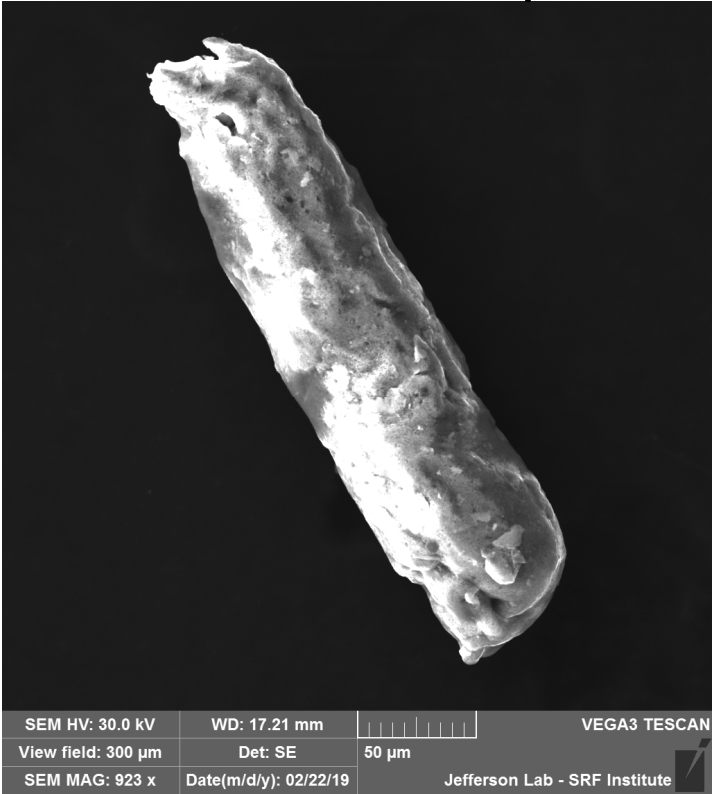
## Titanium – EDS Spot 4

| Element | Weight % | Atomic % | Net Int. | Error % |
| C K | 18.49 | 32.07 | 151.75 | 8.83 |
| O K | 37.13 | 48.36 | 215.66 | 11.52 |
| AlK | 1.28 | 0.99 | 77.38 | 13.12 |
| TiK | 40.50 | 17.61 | 4072.60 | 1.44 |
| FeK | 2.60 | 0.97 | 156.60 | 8.44 |

One of the largest Titanium particles found to date with atypical appearance.

- **Fiber Glass** – EDS Spot 1
- **Copper particle with nickel, silver, steel and chlorine** – EDS Spot 2
- **Steel** with **copper** & **MoS** – EDS Spot 3
- **Titanium** with **aluminum** and **Iron** – EDS Spot 4
- **Silver** with **sulfur** and **chlorine** – EDS Spot 5
- **Fiber** – EDS Spot 8
- **Mineral** – EDS Spot 13
