A TRANSVERSE BEAM INSTABILITY IN THE PEP-II HER INDUCED BY DISCHARGES IN THE VACUUM SYSTEM*

U. Wienands[†], S. DeBarger, W. Colocho, F.-J. Decker, S. Ecklund, A. Fisher, J. Fox, A. Kulikov,
A. Novokhatski, M. Stanek, M.K. Sullivan, W. Wittmer, D. Wright, G. Yocky;
SLAC, Stanford, CA, USA

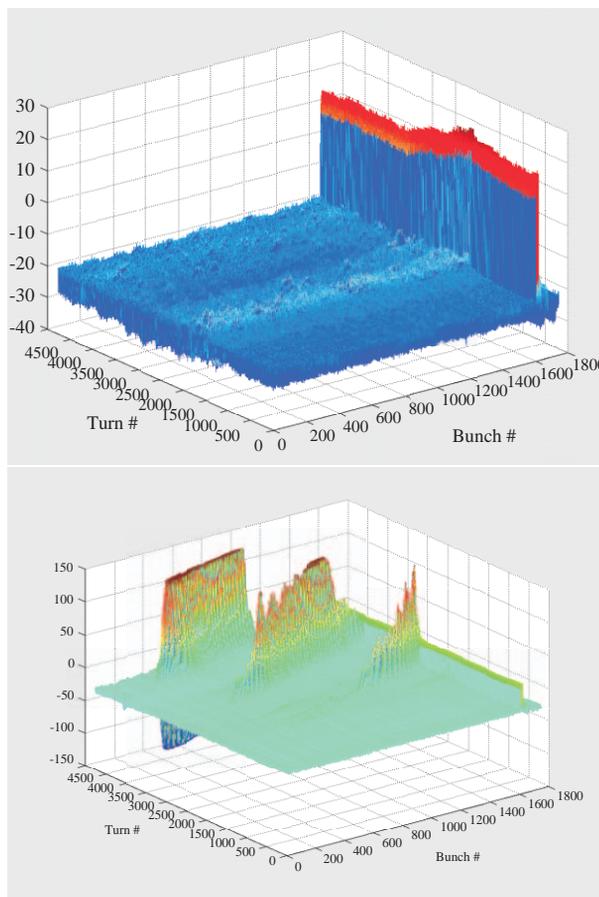
Two different signatures have emerged, termed "tiny Y" and "Ridge" according to the visual signature seen on a 3-d plot of beam position *vs* turn# and bunch#. Figure 1 shows an example of each. The data are acquired upon a beam abort with a fast digitizing system using signals from the transverse feedback systems[1]. Vacuum activity was seen coincident with many (though not every) occurrences of either instability.

Figure 1: Transverse motion of "Tiny Y" instability (top, the abort gap is at high bunch numbers; "tiny-Y" motion starts at about turn 1500) and "Ridge" instability (bottom).

As time progresses a wave of motion is moving from the head towards the tail of the beam, Fig. 1, bottom. At the kicker gap, the process appears to be interrupted, bunches at the head of the train tend to have rather smaller amplitudes of oscillation. The modal decomposition of the motion is shown in Fig. 5. A cluster of modes around 5...10 is growing to dominance. Overall amplitude of the oscillation is much larger than in the "tiny Y" case, somewhat

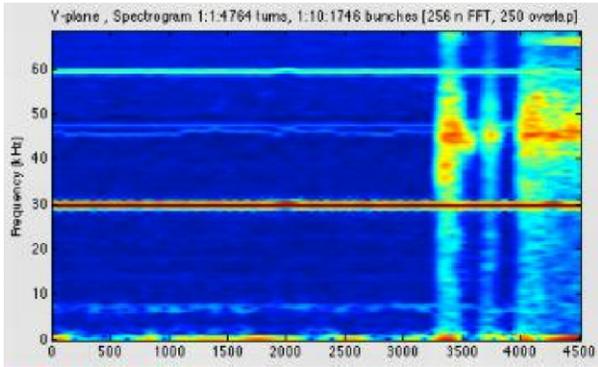
This instability is characterized by quite small coherent amplitude, setting in along the whole bunch train at once. The spectrogram (tune *vs* time, Fig. 2) is rather noisy although it is clearly dominated by the vertical betatron frequency. Occasionally the horizontal betatron tune is also seen with significant, or even dominant amplitude. The similarity to the "fast vertical" instability in the LER[2] is rather striking even though in case of the HER there is no observable effect in the longitudinal plane. The modal spectrum is shown in Fig. 3 for the first 20 modes. There appears to be rapid initial growth of the 0 mode whereas a cluster around modes 8...10 is seen to grow at a slower rate, when the 0 mode is actually damping.

Figure 2: Spectrogram of "tiny-Y" instability.

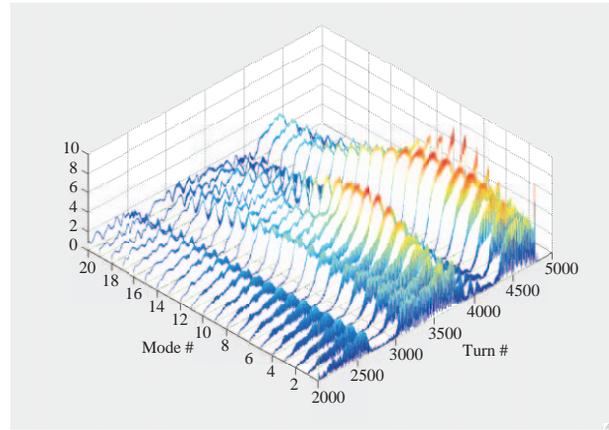
Figure 5: Modal spectrum *vs* turn # of "Ridge" instability.

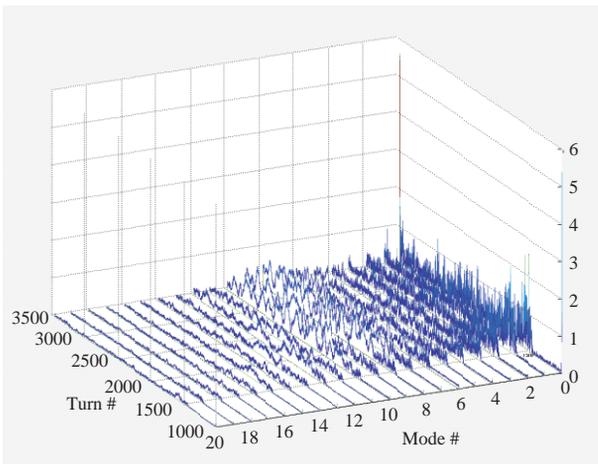
Figure 3: Modal spectrum *vs* turn # of "tiny-Y" instability.

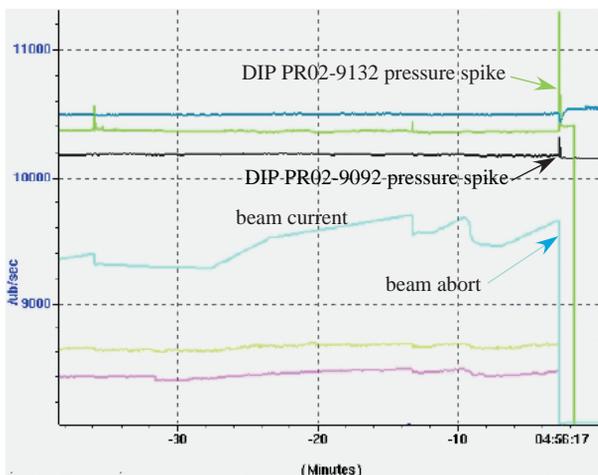
observed, as shown in Fig. 4. Analysis of a number of such events allowed us to identify a few locations in the HER where vacuum components may be failing. This evidence is sometimes corroborated by thermal activity.

Figure 4: Vacuum pressure spike at a beam abort.

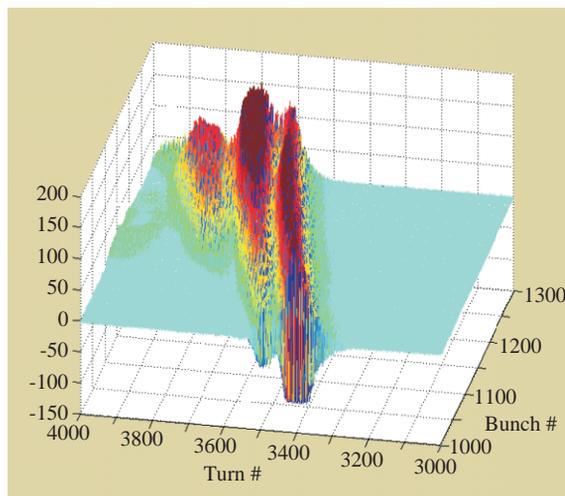
The "Ridge" type instability suggests a mechanism coupling the bunches together. The appearance suggests a disturbance that originates at a certain point in time and via bunch-to-bunch coupling travels along the train until it reaches the gap, which appears to a certain extent stopping the disturbance. After that it may start again. The dominance of modes 5. . . 10 arises from a fine-structure visible within the ridges in Fig. 1 as shown in the magnified view in Fig. 8. The period of the fine structure is 60. . . 100 turns depending on the amplitude, or a frequency of about 1 to

a few MHz. This is consistent with typical ion-oscillation frequency in the HER, seen e.g. when vacuum conditions are poor[4]. We therefore may conclude that the observed instability indeed is consistent with being induced by ions.

Figure 8: Fine structure of beam motion within a ridge.

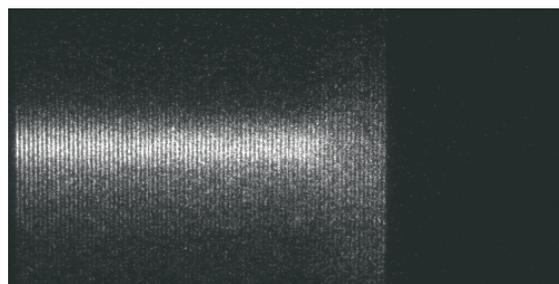
The "tiny-Y" signature is different and defies an easy explanation. The small observed amplitude is inconsistent with the radiation it caused in the BaBar detector. However, there is evidence of bunch growth from fast synchrotron light monitoring, Fig. 9, hinting at a single-bunch effect or at scattering of particles off material. The rather similar "fast vertical instability" seen in the LER[2] was most likely caused by metal vapor injected into the beam. These potentially fairly heavy and ionized objects may not move appreciably on the time scale of the observation (35 ms); on the other hand, if quantity and state of ionization are sufficiently high they may affect the beam motion, leading to the small observed coherent signal.

Figure 9: Vertical bunch size *vs* time, 80 turns increment.
