EXPERIENCE WITH LONG TERM OPERATION WITH DEMINERALIZED WATER SYSTEMS AT DAANE

L. Pellegrino, LNF – INFN, Frascati (Roma) - Italia

During eight years operation of the DAANE water cooling system some critical situations have been successfully managed by upgrading the demineralized water system. The collected data and the experience gained in the field of copper corrosion and related water treatment are critically revised.

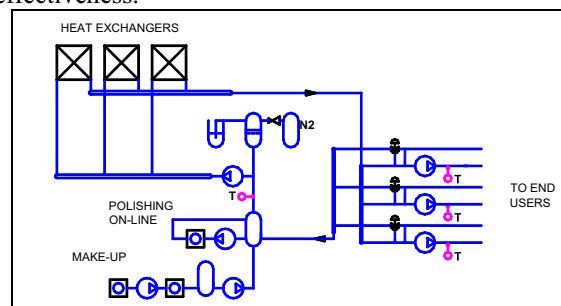
Figure 1: Cooling system (secondary circuit) design.

In figure 1 is represented the Main Rings cooling system. Note the position of the cushioned expansion tank, affecting the pressurization level of the whole secondary circuit, as well as the polishing on-line, whose insertion point plays a crucial role in its effectiveness.

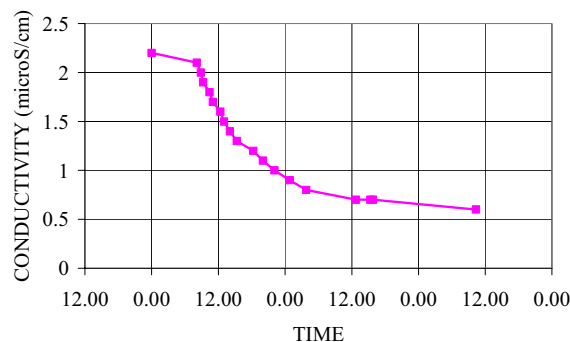
Figure 2: water conductivity vs. time after a shut-down.

The time of recovery is quite long, as reported in figure 2, so the full stop, leading in few days to conductivity of more than 2 µS/cm, is limited only to

the case of scheduled long pauses for major accelerator improvements or new experiments set up.
