# LONG-TERM STABILITY OF THE BEAM POSITION MONITORS AT SPRING-8

T. Fujita<sup>#</sup>, H. Dewa, M. Masaki, S. Matsubara, S. Sasaki, S. Takano,  
Japan Synchrotron Radiation Research Institute (JASRI/SPRING-8), Hyogo, Japan  
H. Maesaka, Y. Otake,  
RIKEN SPRING-8 Center, Hyogo, Japan

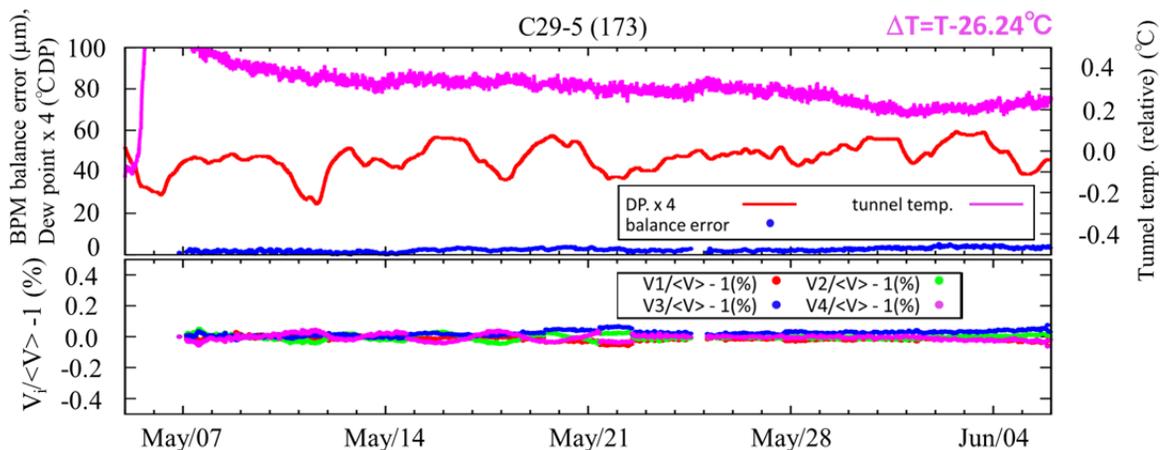
An example of trend of the balance error of the SPring-8 BPM for one operation cycle of SPring-8 (2<sup>nd</sup> run of 2015FY, May/07-June/06) is shown in Fig. 2. The upper panel shows balance error defined in the previous section with the environment data, the temperature and the DP. The temperature is measured in the accelerator tunnel near the BPM. The DP is calculated from the temperature and humidity measured by the air-conditioning system for the tunnel. The lower panel of Fig. 2 shows voltages for each electrode channel normalized by the mean of the four, subtracted by the initial values in the plot. The BPM shown in Fig. 2 is stable and the balance error is less than 5  $\mu\text{m}$ . Slight fluctuations in each voltage reflect actual orbit fluctuations.

Figure 2: An example of stable BPM. Peak-peak variation of balance error was ~5 µm. Slight variations in voltages are due to beam orbit variation. Legends are common for Figs. 3-6.
