X-RAY TOMOGRAPHY INSPECTION OF SRF CAVITIES*

E. Harms#, Fermilab, Batavia, IL 60510, U.S.A
H. Edwards, Fermilab and DESY, Hamburg, Germany

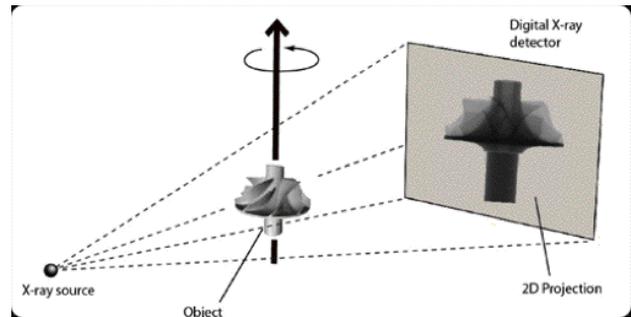
Figure 1: Overview of 2-dimensional imaging technique. Courtesy of North Star Imaging, Inc.

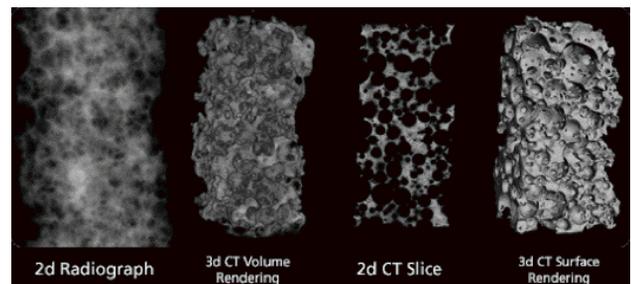
Figure 2: Steps taken in producing three-dimensional computed tomography images. Courtesy of North Star Imaging, Inc.

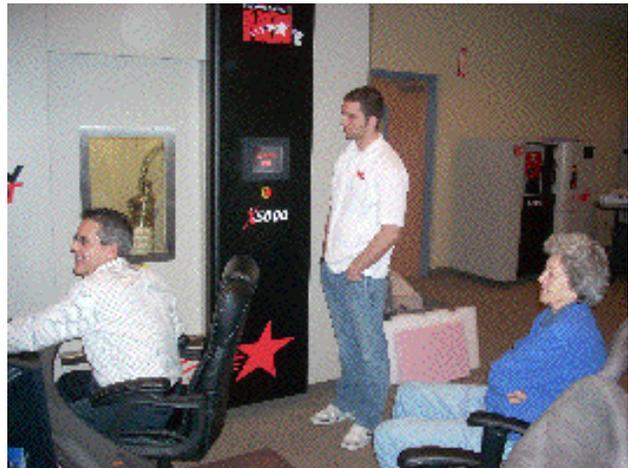
In figure 6 it is possible to see the size of the X-ray machine with Fermilab and North Star Imaging staff witnessing a 3.9 GHz 9-cell cavity under analysis.

Figure 6: 3.9 GHz dressed Cavity undergoing imaging at *North Star Imaging, Inc.*

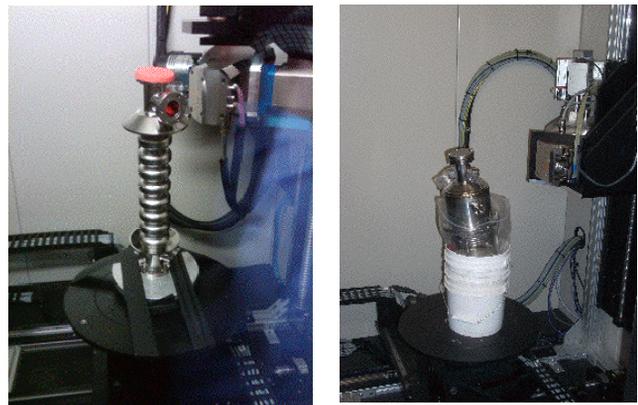
Orientation of the device or area to be studied with respect to the incident X-ray beam and detector is critical to successful tomography. Figures 7 and 8 show both a bare and dressed 3.9 GHz cavity mounted for imaging with a slight tilt so as only minimal interference with the input coupler and HOM feed through flanges as well as conical end groups are encountered.

Figures 7 & 8: 3.9 GHz cavities in the X-ray machine mounted for imaging. The X-ray gun is to the right in both photos.

In both cases, the exercise proved to be successful as fractures near the weld joint of the back-side ‘F-piece’ leg were clearly visible. With CT reconstruction software it is possible to look at the result from virtually any angle or magnification. The size of the fracture in this case is estimated to be of order 0.1’s of a mm.

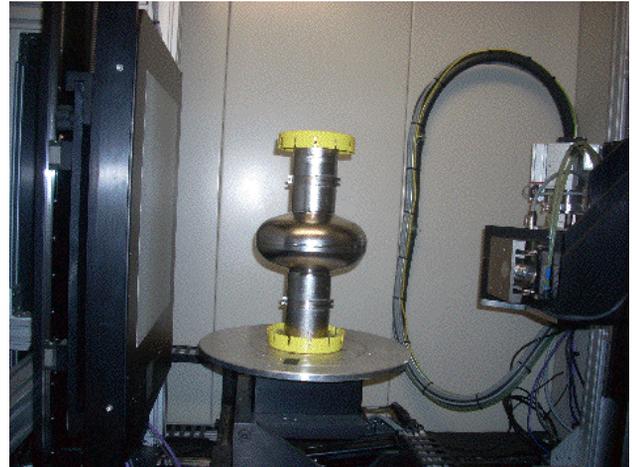
The first candidate to be imaged was a cavity with a known low quality equator weld as evidenced by visual inspection. Figure 11 shows a representative cavity under assessment at *North Star Imaging*.

Figure 11: 1.3 GHz single cell cavity under test. To the cavity's left is the detector screen and to the right is the X-ray gun in its resting position.

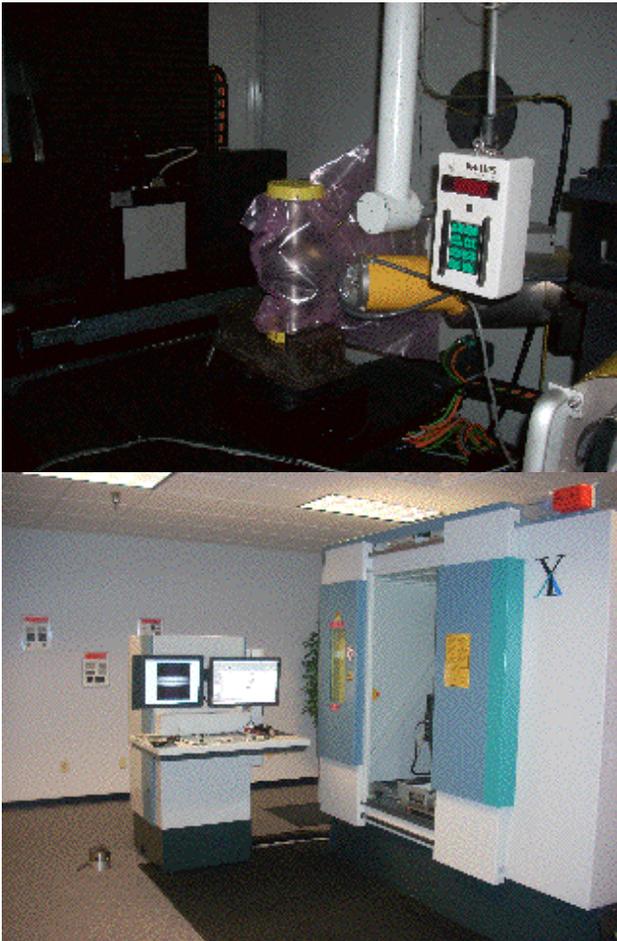
Both firms offer imaging and analysis services as well and also manufacture and sell their own lines of X-ray machines. The devices offered by each are very similar. Figures 17 and 18 are images of a cavity being prepared for test at *YXLON* and a view of their system. The *YXLON* hardware compares favorably to the *North Star Imaging* system seen in Figure 6. Both vendors offer relatively fast turn-around and availability and nearly ‘same day’ service in terms of producing image results. Similar techniques are offered as to how the imaging is performed and system operating parameters.

Figures 17 & 18: X-ray imaging system at YXLON/Comet Technologies in Akron, Ohio.
