CAVITY INSPECTION AND REPAIR TECHNIQUES

K. Watanabe[#], H. Hayano, KEK, Tsukuba, Ibaraki, Japan

Abstract

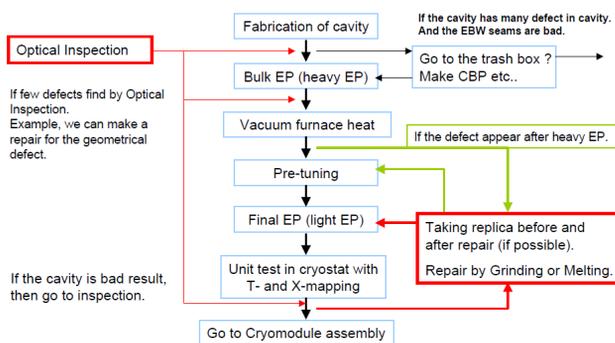
Figure 1 shows the example of inclusion of the defect repair process into the cavity treatment flow. We use the repair with combination of local grinding and light EP, in order to avoid the heavy EP, the vacuum furnace heating and the pre-tuning. The repair methods are under development at labs around the world. They are the local grinding, local re-melting by electron beam or laser and the tumbling. We can choose a method from them according to the type and the number of defects. It should be noted that the electro-polishing also change defect shapes.

Figure 1: Repair process inclusion for the cavity treatment flow.

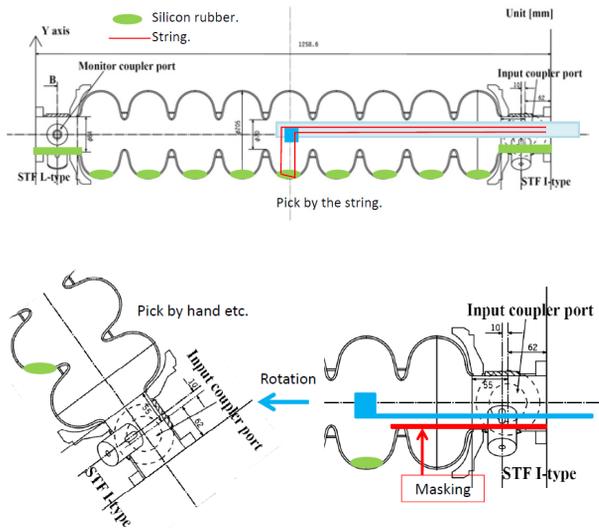
The replica can be taken from all the cell equators by the special tool. The beam tube and the tapered wall area of cell #1, #2, #8, #9 can be replicated by masking and picking by hand with cavity tilt respectively (see Fig 2). The special tool for the cell equators was developed in Feb 2010. The replica material is a silicon rubber.

Figure 2: Several method to take replica.

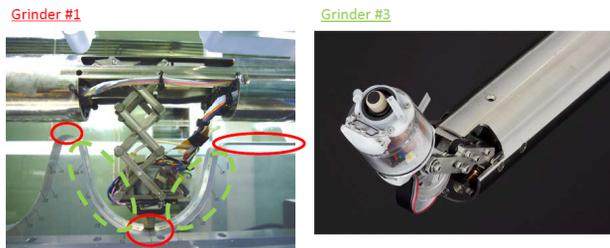
Two types of grinders were developed to remove defects on an equator, an iris, a beam tube and a tapered area of a cell (See Fig 3). The grinder #1 can treat a plane parallel to the beam axis. The grinder #3 treats backside of stiffener ring and a tapered wall of the cell. The small USB camera with LED light is equipped on the grinder head. The diamond sheet or 3M Scotch Brite are used for grinding and polishing the inner surface of the cavity.

Figure 3: Grinding machines and grinding area. Grinder #1 is for red area, and grinder #3 is for green area.
