# RADIATION DOSE MEASUREMENTS AND A STUDY OF DAMAGE TO ACCELERATOR COMPONENTS IN THE TRISTAN e<sup>+</sup>e<sup>-</sup> COLLIDER AT 27.5 GeV

T. Momose, H.Hirayama, T.Ieiri, K.Takayama, Y.Ohsawa, K.Endo, H.Ishimaru, Y.Mizumachi, S.Takeda, T.Kawamoto and K.Uchino National Laboratory for High Energy Physics, 1-1 Oho, Tsukuba-shi, Ibaraki-ken, 305, Japan

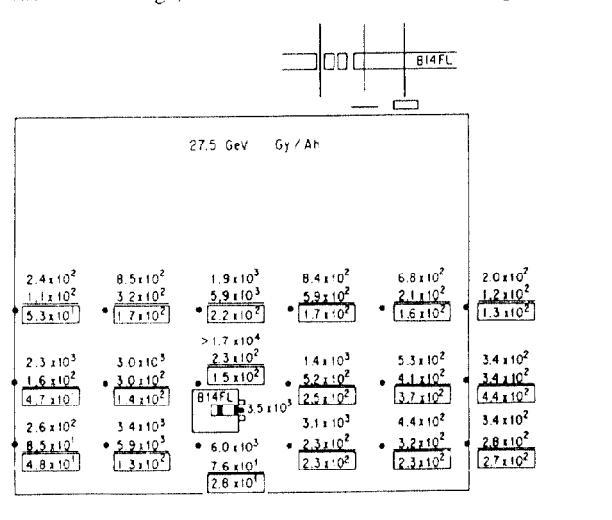
Figure 1 Dose rate distribution over a tunnel cross section at the midpoint of a dipole ([]), near the end of a dipole (-) and between the dipole and a quadrupole magnet ().

Figure 1 shows the dose rate distribution over a tunnel cross section at the midpoint of a dipole, near the end of a dipole, and between the dipole and a quadrupole magnet. The vacuum chamber inside the dipole magnet was covered with a 2 cm thick lead shield on the outer face, and a 1 cm thick shield on the inner face. The chamber outside the dipole was shielded with 1 cm of lead.

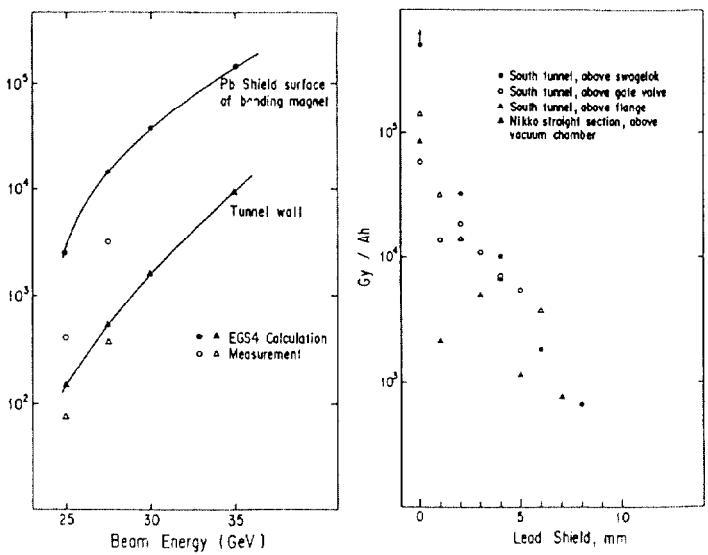
Figure 2 Beam energy dependence of measured and calculated dose rates.

The dose measurements were compared to calculations using the EGSA4 Monte Carlo code<sup>2</sup>. Fig. 2 shows the comparison at 25 GeV. The calculated dose rates exceed the measured ones by about a factor of 5 at the shield surface of the dipole magnet, but the beam energy dependence is well reproduced. For a beam energy of 35 GeV the calculations predict a dose rate of  $3 \times 10^4$  Gy/Ah at the shield surface, and  $7 \times 10^3$  Gy/Ah at the tunnel wall.

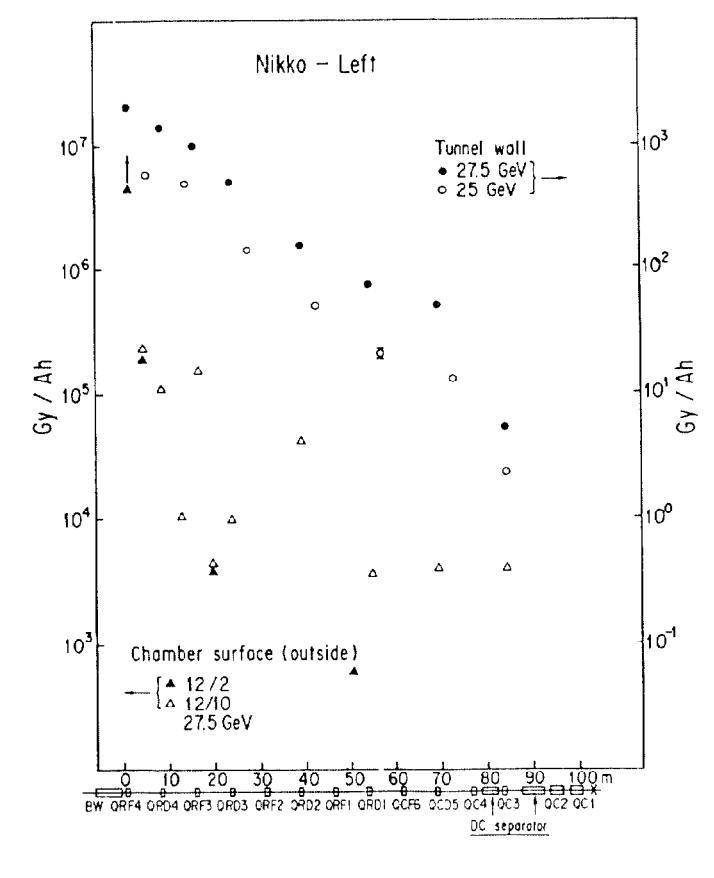
Dose rates at 27.5 GeV for the straight section "Nikko-Left" are shown in Fig. 4. For both the chamber surface and the tunnel wall, the dose rate falls exponentially with distance from the arcs. The chamber surface dose shows, however, some sudden peaks, especially behind some quadrupole magnets. Fig. 4 also shows earlier measurements at 25 GeV. The dose at the tunnel wall has doubled when the beam energy was raised.

Figure 4 Dose rate at 27.5 GeV for the straight section "Nikko-Left" as a function of distance from the arcs (left side).
