# MECHANICAL CONSOLIDATION OF THE LHC INNER TRIPLET MAGNET SUPPORTING SYSTEM FOR REMOTE ALIGNMENT

F. Micolon, N. Bourcey, J. B. Deschamps, A. Herty, S. Le Naour, T. Mikkola, V. Parma, D. Ramos, V. Rude, M. Sosin, CERN, 1211 Geneva 23, Switzerland

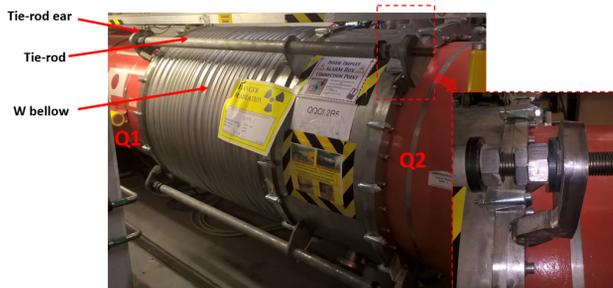
In order to cope with the longitudinal loads due to vacuum forces, between magnets and then to the DFBX which is anchored to the ground, the magnet vacuum vessels are rigidly linked by tie-rods placed outside of the interconnection bellows (see Fig.1).

Figure 1: As-installed view of the Q1-Q2 interconnection.

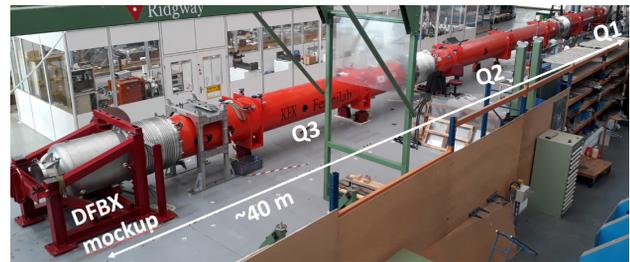
Figure 6: Layout of the triplet string test in 2019.

On initial vacuum pumping, the magnet Q1 moved back by 9.5 mm. Overnight the building air temperature had decreased by about 5°C so the next morning the magnet was found to have moved further back by 1.5 mm due to thermal contraction of the magnet string.

It was then concluded that the interconnect tie-rod system as installed was indeed not stiff enough to prevent a large longitudinal movement of the Q1 magnet in operating conditions. With time, because of temperature variation and friction release, this brought one of the Q1 magnet jack in contact with its body and some transverse vacuum load was then supported by the jack body itself. When operated in this situation, with a transverse load on the jack head, large friction effects within the jacks impair their magnet vertical realignment capabilities. In the different situation tested, vertical realignment was however always possible provided the friction force was overcome, with no measurable stick slip effect. The radial realignment was always possible and was seemingly unaffected in the various situations tested on our setup.
