Recording: Chunguang Jing, Euclid Techlabs, LLC

Side coupled accelerating structures are popular in the industrial realizations of linacs due to their high shunt impedance and ease of tuning. We designed and fabricated a side-coupled X-band accelerating structure that achieved 133 MOhm/m shunt impedance. This structure was fabricated out of two halves using a novel brazeless approach. The two copper halves are joined together using a stainless steel joining piece with knife edges that bite into copper. This structure had been tested at high power at SLAC National Accelerator Laboratory. The performance of the structure had been limited by magnetic breakdowns on the side-coupling cells. In this paper we will present results of the high gradient tests and after-test analysis. Scanning electron microscopy images show a typical magnetic-field induced breakdown.

# X-band Brazeless side-coupled accelerator

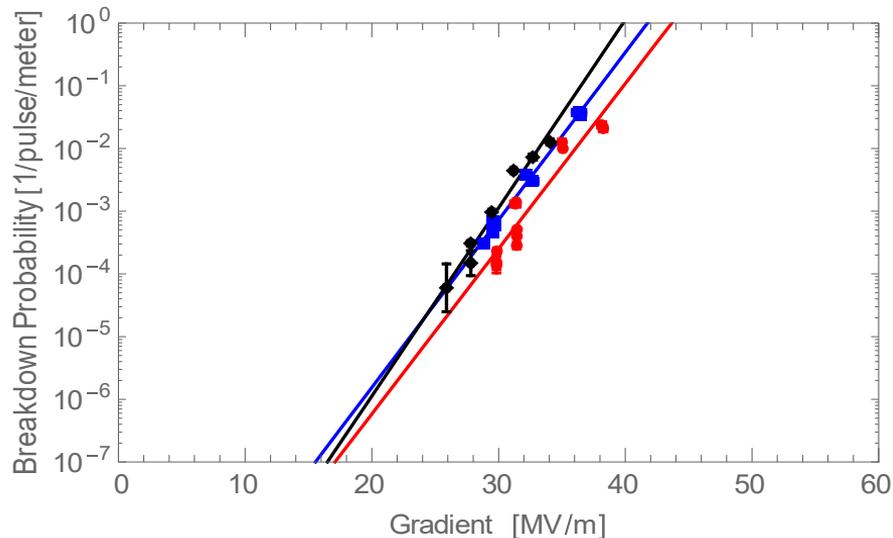
When we compare structure with the same  $E_{peak}/E_{acc}$  and wildly different  $H_{max} * Z_0 / E_{acc}$  (3.3 in side-coupled vs 1.1 in on-axis coupled), we see that peak magnetic field or associated with it peak pulse surface heating is much better predictor of breakdown rates than the peak surface electric field.

Comparison of performance of this prototype side-coupled and SLAC on-axis coupled (SLAC A3.75-T2.2-Cu) structures with similar ratio  $E_{peak}/E_{acc} \sim 2.6$  shaped pulse with **600 ns** flat part, all breakdowns
