THE FAILURE OF THE ALTERNATORS OF THE NIMROD MAIN MAGNET POWER SUPPLY

H. G. Brooks  
Rutherford High Energy Laboratory, England

A. B. D. Reed  
English Electric Co., Ltd., England

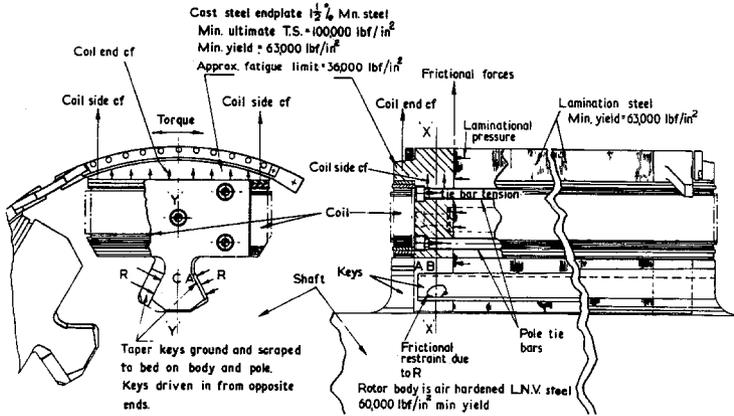
Fig. 2 Original pole construction

The effects of gravity on the pole stresses had been examined but the variable stress on the neck due to the self weight of the pole, was small. It however acts in a more subtle way. Due to the sag of the shaft there is a very small angle  $\epsilon$  (Fig. 5) between the catenary line at the endplate and the axis A B. This means that the effective pole length oscillates between C D and E F producing changes in lamination pressure and a resulting rotational frequency bending about the X X axis (Fig. 2). This stress variation is a feature of all horizontal machines of keyed laminated pole construction.
