## SRF Accelerating Modules Repair at DESY.

D. Kostin\*, J. Eschke, B.v.d. Horst, K. Jensch, N. Krupka, L. Lilje, A. Muhs, D. Reschke, S. Saegbarth, J. Schaffran, M. Schalwat, P. Schilling, M. Schmoekel, S. Sievers, N. Steinhilber-Kuehl, E. Vogel, H. Weise, M. Wiencek, DESY, Hamburg, Germany.

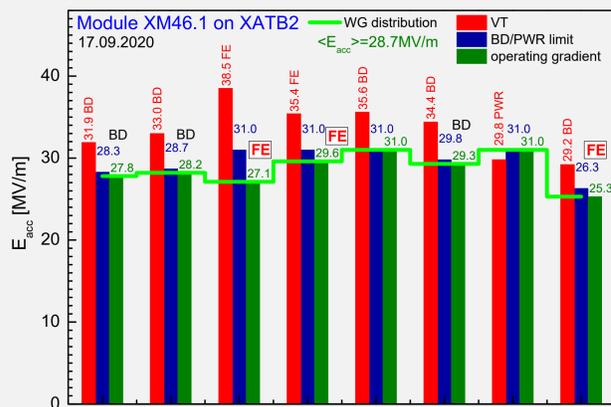
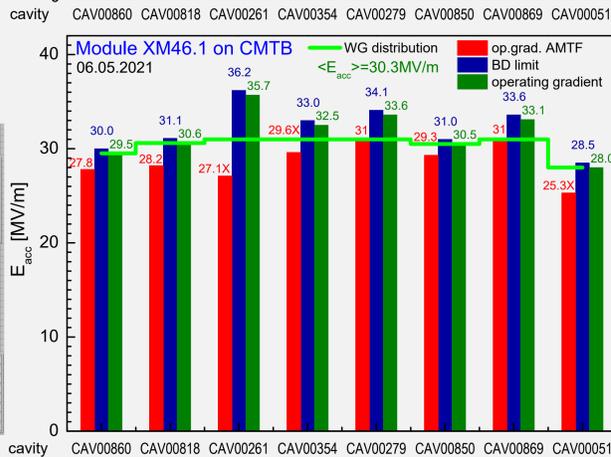
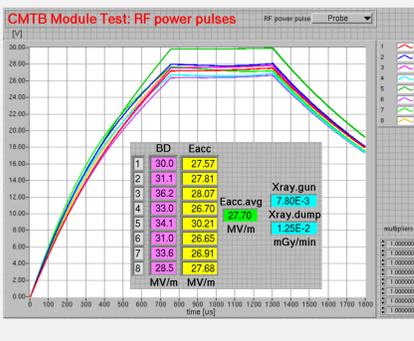
### XM46.1 testing history

- Module XM46 was delivered to DESY in Sep. 2015 after the assembly at CEA (Saclay).
- Module XM46 1<sup>st</sup> test in Oct. 2015 showed a degradation of the cavity performance with a very high Field Emission.
- Decision was taken not to install/use the module in the Eu-XFEL and re-assemble it after cavities' re-treatment.
- After disassembly XM46 cavities underwent HPR at DESY and after Vertical Test (VT) were accepted for XM46.1 assembly.
- XM46 was re-assembled at DESY to XM46.1 and successfully tested in Sep. 2020.
- The module was tested on two test-stands at DESY: AMTF and CMTB: successful module repair is confirmed on both. Currently a CW module test on CMTB is ongoing.

- Module XM46.1 showed good performance: the repair was immediately successful. Also transport from AMTF and installation on CMTB did not change this. Module was stored and transported with cavities string under vacuum.
