MAXIMISING BEAM AVAILABILITY AT THE AUSTRALIAN SYNCHROTRON

J. Trehwella, D. Morris, G. S. LeBlanc, D. McGilvery, Australian Synchrotron Company, Clayton, Victoria 3168, Australia

Abstract

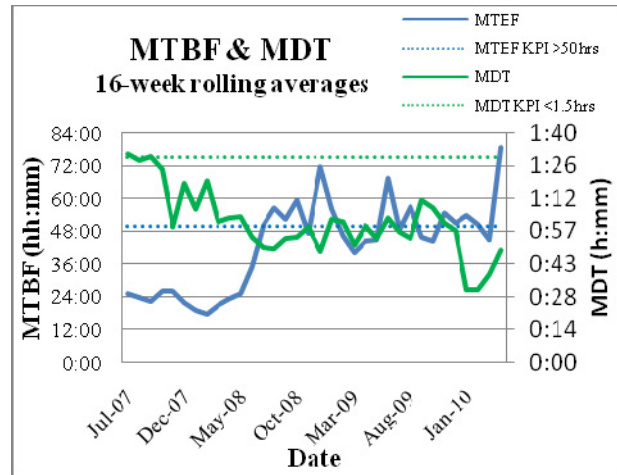
Figure 2: MTBF and MDT for 16 week rolling averages [1]

This achievement has also directly improved the MTBF and MDT respectively (see Fig. 2). With KPI's of greater than 50hrs for MTBF and less than 1.5hrs for MDT, we are currently meeting these performance goals.

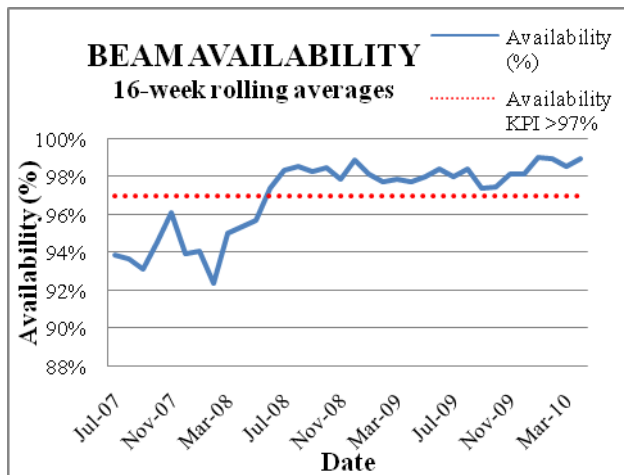
Figure 1: Beam Availability for 16 week rolling averages [1]

One of the most important Key Performance Indicators (KPI) for the Australian Synchrotron, now into its 4th year of operations, is beam availability greater than 97%. In striving to actively improve performance and reliability in many areas, it was realised that one of the major factors in maximising availability, is implementing preventative measures and recovery procedures after an unscheduled beam loss [2]. By successfully implementing improvements in these areas, we have already managed to achieve availability > 98%, which is above our long term target (see Fig. 1).
