Beam Trip Diagnostics for the TPS

C. Y. Liao*, C. Y. Wu, Y. S. Chen, C. H. Huang, K. H. Hu, K. T. Hsu National Synchrotron Radiation Research Center, Hsinchu 30076, Taiwan

The 2017 International Beam Instrumentation Conference, WEPWC07, 20-24 August, 2017

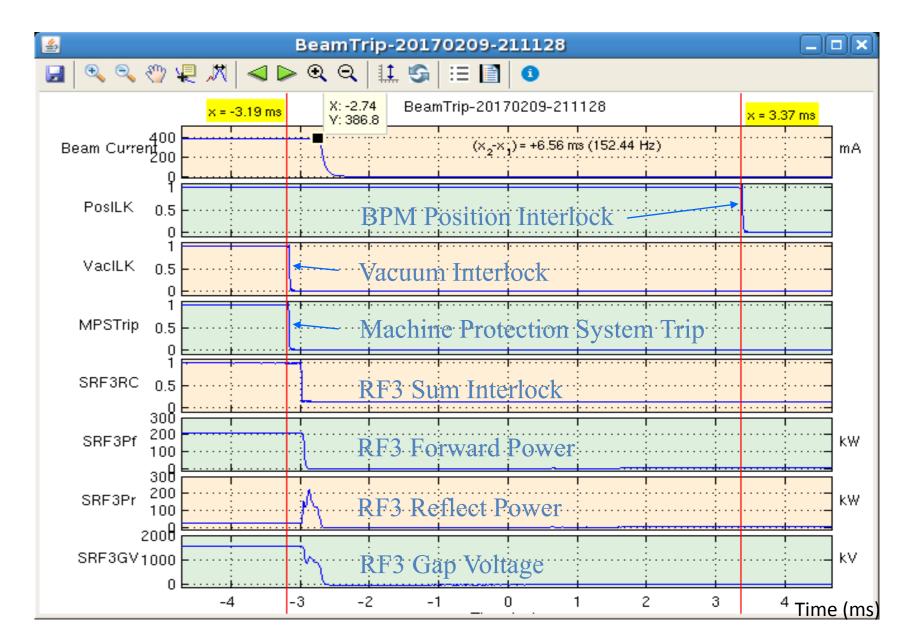
Fig. 3: Plot page of vacuum interlock event.

It can list the beam trip event with a simple note, and a signal list check box can be used to select the desired data for display (as shown in Fig. 3), which can be downloaded from the server using the FTP.
