SURFACE CHARACTERIZATION OF THE LCLS RF GUN CATHODE*

A. Brachmann[#], F.-J. Decker, Y. Ding, D. Dowell, P. Emma, J. Frisch, S. Gilevich, G. Hays, Ph. Hering, Z. Huang, R. Iverson, H. Loos, A. Miahnahri, D. Nordlund, H.-D. Nuhn, P. Pianetta, J. Turner, J. Welch, W. White, J. Wu, D. Xiang SLAC National Accelerator Laboratory, Menlo Park, CA 94025, USA, U.S.A.

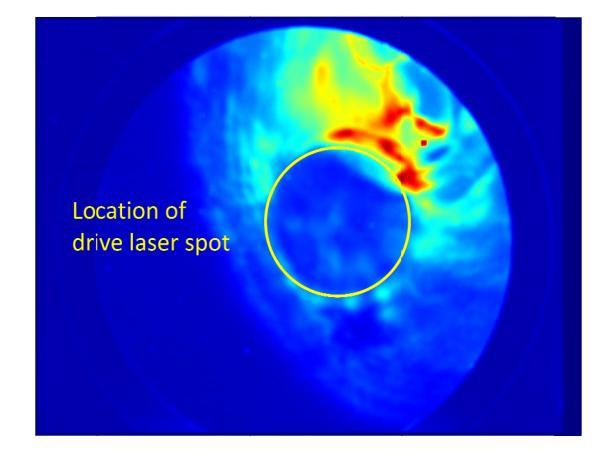
The first copper cathode installed in the LCLS RF gun was used during LCLS commissioning for more than a year. However, after high charge operation (> 500 pC), the cathode showed a decline of quantum efficiency within the area of drive laser illumination (fig. 1). We report results of SEM, XPS and XAS studies that were carried out on this cathode after it was removed from the gun. X-ray absorption and X-ray photoelectron spectroscopy reveal surface contamination by various hydrocarbon compounds. In addition we report on the performance of the second installed cathode with emphasis on the spatial distribution of electron emission.

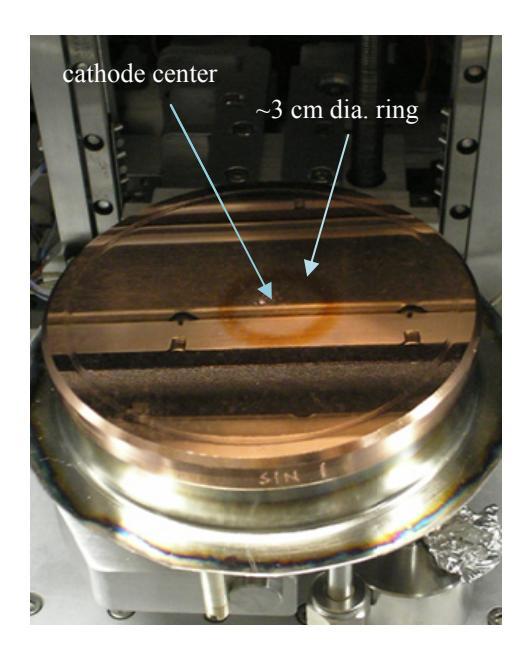
Figure 2: circularly shaped 'dark ring' contamination of cathode surface

We assumption the reason for the decay of the cathodes quantum efficiency is the contamination of its surface by hydrocarbon species contained in the vacuum system of gun and adjacent beam line. The UV drive laser beam and/or the electron beam interact with the residual gas of the vacuum system or already physisorbed species, which are then ionized by drive laser beam and electron beam and deposited on the cathodes surface forming a chemisorbed layer resulting in an increased work function. Upon the removal of the cathode a dark ring of \sim 3 cm diameter on its surface, macroscopically visible, was discovered (fig. 2). It is unclear if the deposition of the ring occurred during RF processing of the gun or if it has formed during normal operation.

To determine the location of the 'dark' ring (see fig. 2), measurements of the C-K1s and Cu-3d peak were performed in a grid pattern and their ratio was used to obtain information on the relative C distribution (fig. 4).

SEM imaging and EDX analysis were carried out on an Aspex PSM-76 LS scanning electron microscope. Various areas of the cathode surface were analyzed. In particular, a clearly macroscopically visible dark ring of surface deposits (\sim 3 cm in diameter), the center of the cathode and other surrounding areas were studied. A variety of features were observed:

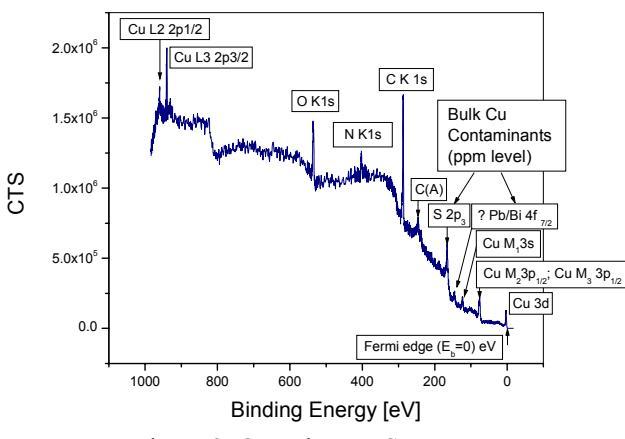
The XPS spectrum indicates a surface layer composition containing oxygen, nitrogen and carbon. A variety of peaks can be attributed to the bulk material (Cu, Pb, Bi and S). An overview spectrum is given in figure 3.

Figure 3: Overview XPS spectrum

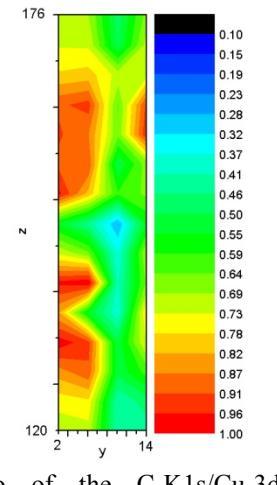
Figure 4: Ratio of the C-K1s/Cu-3d XPS peak (normalized)

The measurement of the spatial distribution of the carbon to copper ratio indicates a continuous layer of carbon species across the entire cathode. The carbon XPS peak (C K1s) was observed at any location on the cathode. A larger fraction of carbon is evidence of a larger thickness of the carbon laver. The XPS measurements of the distribution of the C/Cu ratio confirm the presence and carbon containing composition of the macroscopically visible dark coloured ring. Higher resolution measurements of the C K1s peak at various locations reveal the complex structure of the observed carbon species. Slight intensity shifts of the peaks contributing to the spectrum were found at different locations. Qualitatively, spectra are very similar across all regions of the cathodes surface. The peak at ~ 284 eV indicates the presence of elemental carbon. Deconvolution of the XPS spectra show a main peak of elemental carbon but also indicate a significant fraction of C-O bonds (~288 eV, fig. 5).

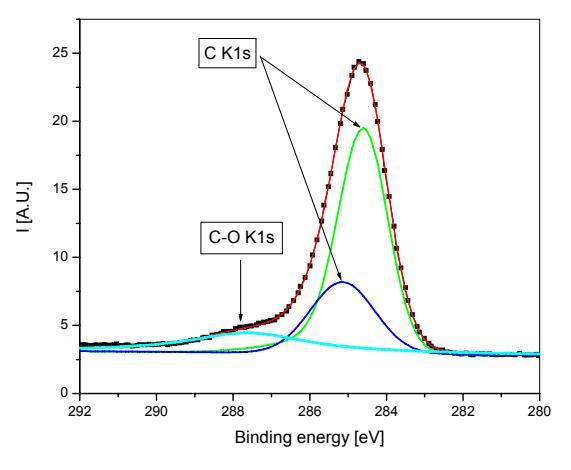
Higher resolution measurements of the carbon peak and peak deconvolution were carried out to resolve the speciation of the surface carbon layer (fig. 5).

Figure 5: Deconvolution of the C K1s XPS peak

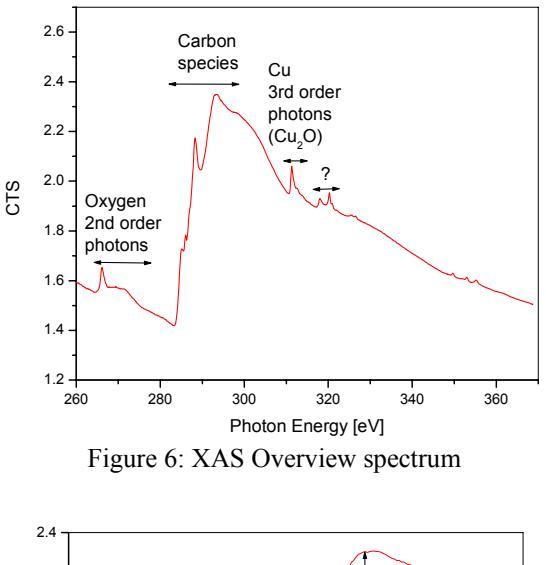
X-Ray absorption spectroscopy was used to further determine the nature of the carbon layer. An overview spectrum is given in fig 6. The spectrum shows the absorption of photons 260 - 370 eV. The main feature is the carbon absorption edge. Adjacent areas of the

spectrum show the absorption spectrum of oxygen and copper species. Both are the result of absorption of higher order photons. A detailed spectrum of the carbon edge is shown in fig. 7.

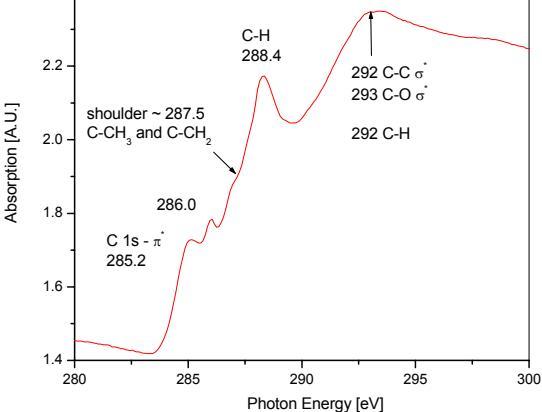
Figure 7: XAS details of Carbon (C K1s) absorption edge

A more detailed carbon speciation is possible using X-Ray absorption spectroscopic measurements of the C K1s absorption edge (see fig. 7). The main identified features are the π^* antibonding state of graphitic carbon located at ~ 285 eV as well as states in the region of 287-289 eV that are associated with C-CHx and C-CH bonds. The broad peak at ~ 292 eV can be attributed to the σ^* orbitals of C-C and C-O bonds. A C-H bond can also be expected here.

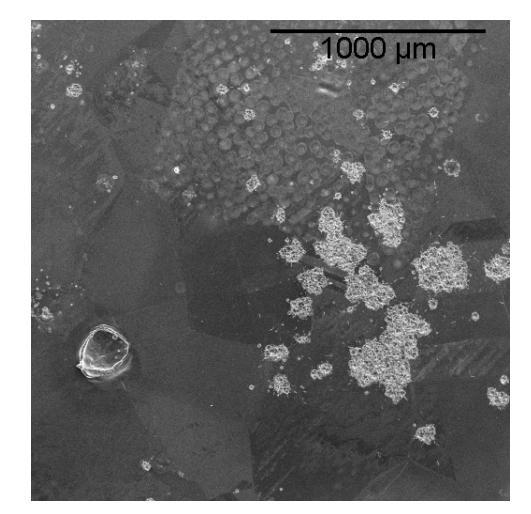
- 1. Surface damage due to RF breakdowns that occurred during RF processing of the gun and cathode (fig. 8).
- 2. Surface perturbations that are results of 'laser cleaning' of the surface (fig 8).
- 3. Contamination by particles

Figure 8: SEM detail of cathode surface: center and lower left – RF breakdown events, upper middle – artefacts of laser cleaning
