## **Review of optical inspection methods and results**

K. Watanabe (KEK)

SRF 2009, September 22, 2009

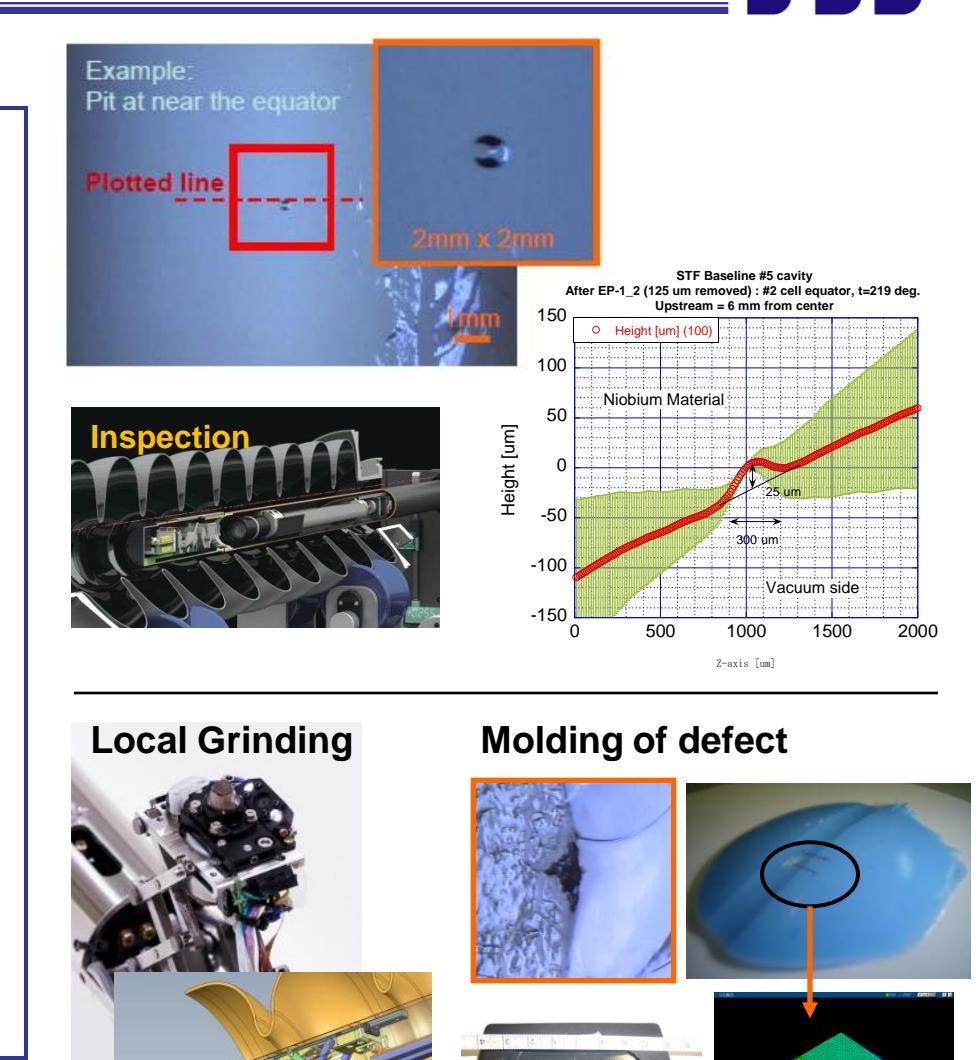
### \* 1<sup>st</sup> inspection at "As received".

Check the EBW seam and Outside of Weld Area at equator and iris.

\* 2<sup>nd</sup> inspection after bulk EP, then shape analysis and marking of the suspicious spots.

\* 3<sup>rd</sup> inspection after Vertical test with Tmap result.

(In case of bad cavity performance and Tmap detected a heating location.)

\* Counter-measure for next test.

\*Molding of defect, \*Local Grinding etc.

\*Rinsing method (Degreaser, Ethanol etc.)

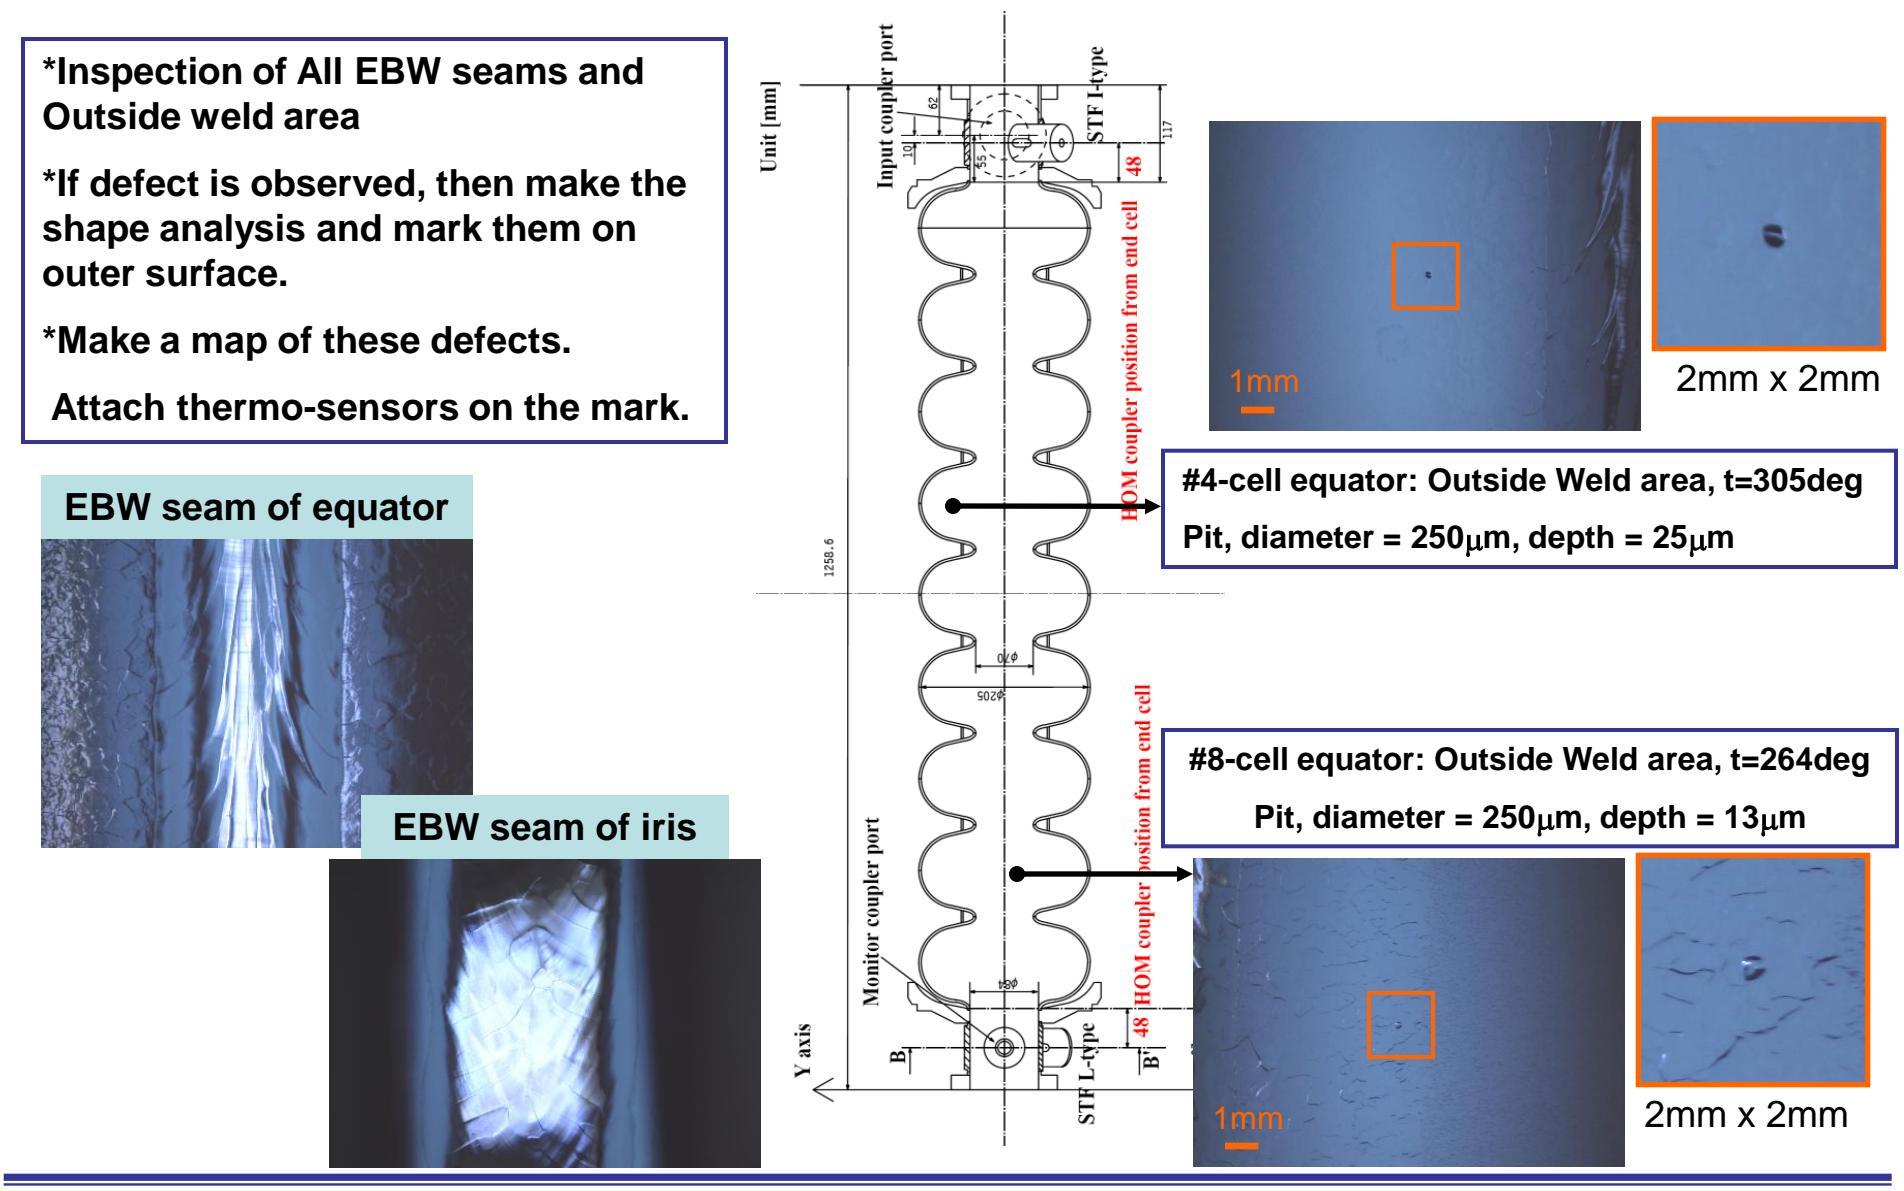
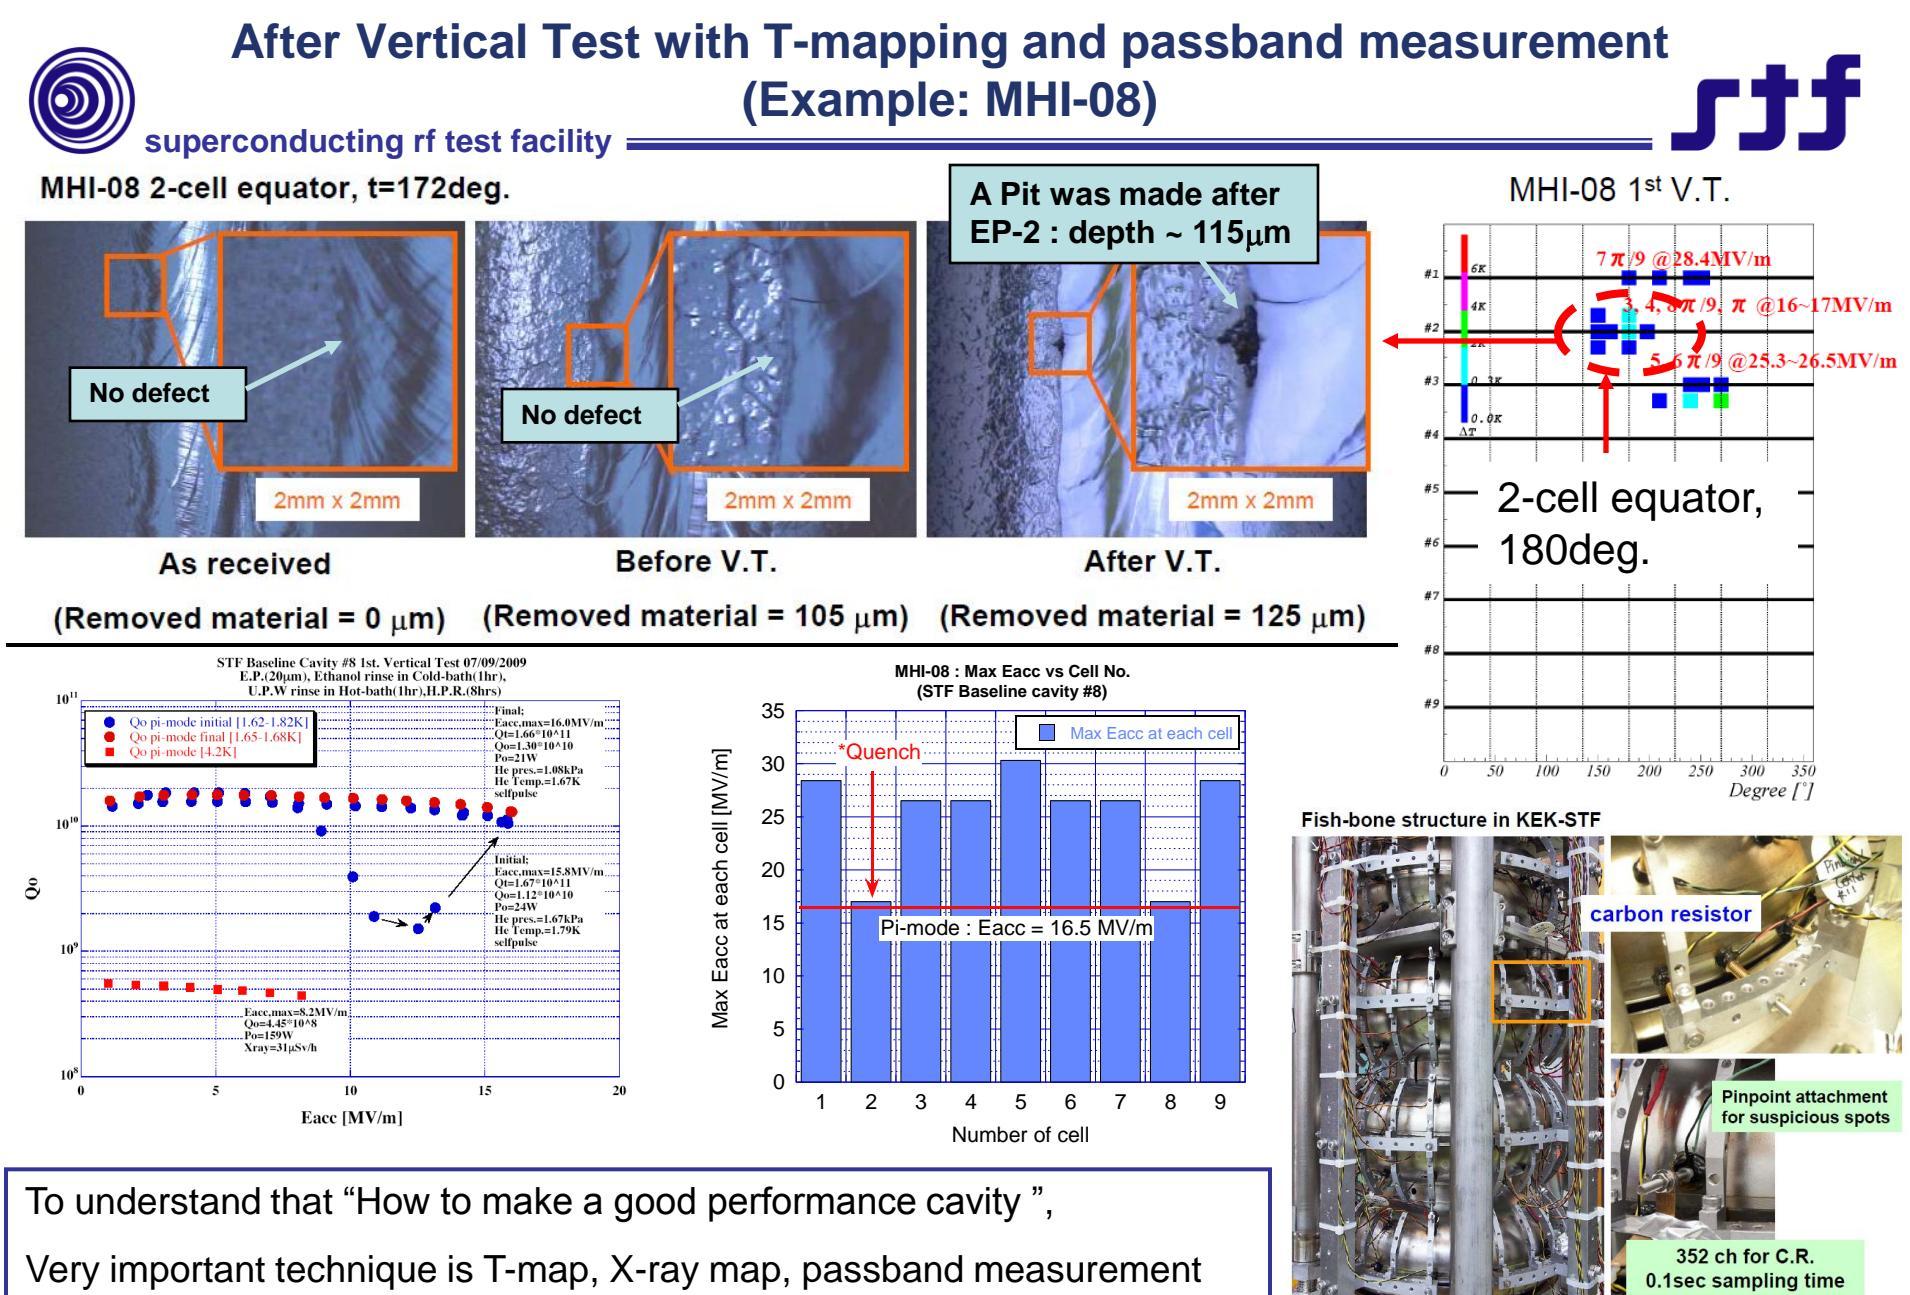
## Inspection before vertical test (Example: MHI-08)

and cavity inspection at "Every" Vertical test and treatment.
