OPERATIONAL EXPERIENCE WITH SUPERCONDUCTING SYNCHROTRON MAGNETS

Philip S. Martin Fermi National Accelerator Laboratory* P. O. Box 500 Batavia, Illinois 60510

The operational experience with the Fermilab Tevatron is presented, with emphasis on reliability and failure modes. Comparisons are made between the operating efficiencies for the superconducting machine and for the conventional Main Ring.

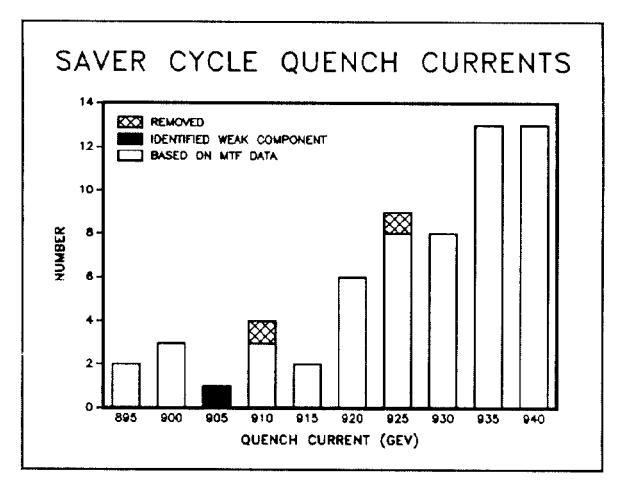
$\label{eq:FIGURE 2} FIGURE \ 2 \\ \mbox{Quench Currents of the Weakest Magnets in the Tevatron}$

Figure 2 shows the Saver Cycle quench currents for the 48 weakest magnets in the ring, based on the original MTF data, prior to the recent removal of the two magnets. Their positions have been indicated, along with the component which has been identified as being the weakest one remaining. There are clearly a few components in the Tevatron which exceed their MTF measurements. Equally clear is that the spectrum is rising; many components would have to be replaced to gain another 25 GeV.
