Improvement of the Extraction Channels of the CERN-SPS Accelerator

R.L. Keizer, K.H. Kissler, R. Oberli CERN, 1211 Geneva, Switzerland

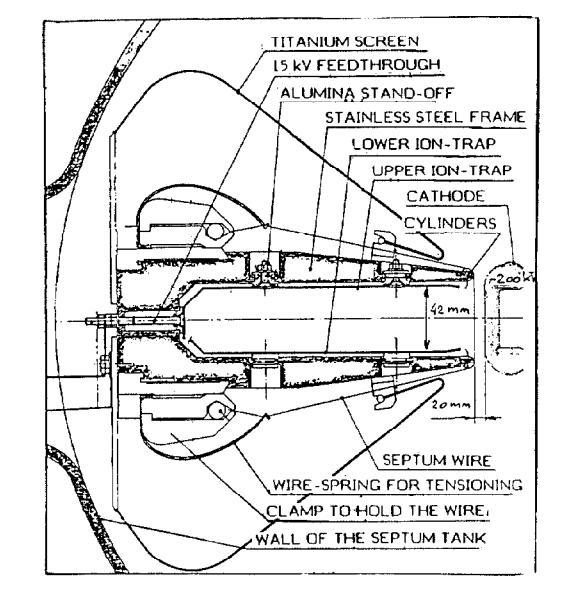
The construction of the 3120 mm long stainless steel anode is shown in Fig. 1. The body consists of

Fig. 1 Construction of the stainless steel anode

a stainless steel U-profil which acts as a frame on which the 100  $\mu m$  thick septum wires are stretched and aligned. The effective septum thickness is 150  $\mu m.$

The problem with the anode body is that the secondary particles scattered by the septum wires heat the body of the anode by some 10°C. These secondaries move forward in a sharp cone. Therefore the stainless steel tips near the septum wires heat faster than the more remote parts of the anode body. The sensitivity of the effective septum thickness to the temperature gradient is  $85 \ \mu m \ ^{\circ}C^{-1}$ . This implies that the thickness doubles with a temperature difference across the anode of only  $1.8^{\circ}C$ .

1 mm thick upper and lower ion-traps are mounted inside the anode. Alumina stand-offs insulate these electrodes electrically and link them rigidly to the anode body.

The weakness of this construction is that there is a strong tendency for the 1 mm thick electrodes, spaced at 2 mm from the anode, to buckle when heated by the secondaries. Calculations show that a temperature difference between anode and ion-trap of only 7 °C causes a short circuit. Visual inspection of the ion-traps indicates the presence of regions half-way between the stand-offs where strong spark erosion occurred.

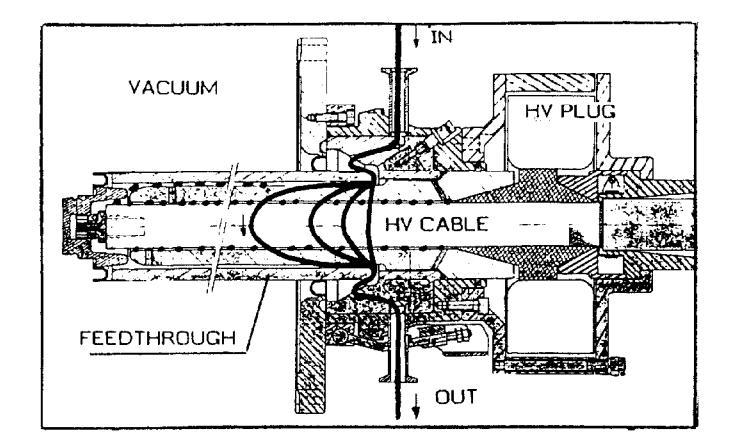
The HV-feedthrough, Fig. 2, which links the HV-cable and the cathode is very sensitive to radiation damage because the dielectric liquid, Freon, is organic. One of the decay products, hydrofluoric acid is removed by continuously circulating the liquid through an active chemical filter. Other decay products in gaseous form cause small bubbles which are trapped because the flow is directed downwards. The space around the cable itself is not ventilated at all. Strong dark currents develop along the PVC surface which therefore has a tendency to carbonize.

Fig. 2 The existing HV-feedthrough and HV-plug

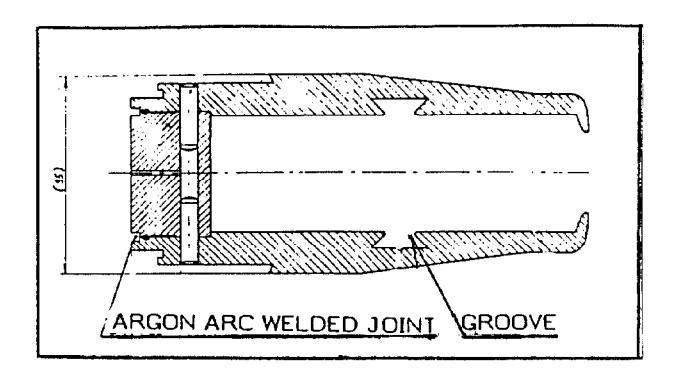
An Invar (36Ni 54Fe) anode replaces the stainless steel body. The sensitivity of the effective septum thickness to a temperature gradient is reduced by one order of magnitude so that a temperature difference of  $1.8^{\circ}$ C will increase the septum thickness by 6% only (instead of 100%). Furthermore, compared with the old system, 3x more p-intensity is needed to cause this difference of  $1.8^{\circ}$ C.

The anode body is assembled from 3 pieces as shown in Fig 3.

Fig. 3 Construction of the 3160 mm long INVAR anode

The beam shrinks during acceleration. Therefore the free height between the noses may be somewhat reduced, the advantage being that the anode is rigidified and the length of the septum wires is shortened.

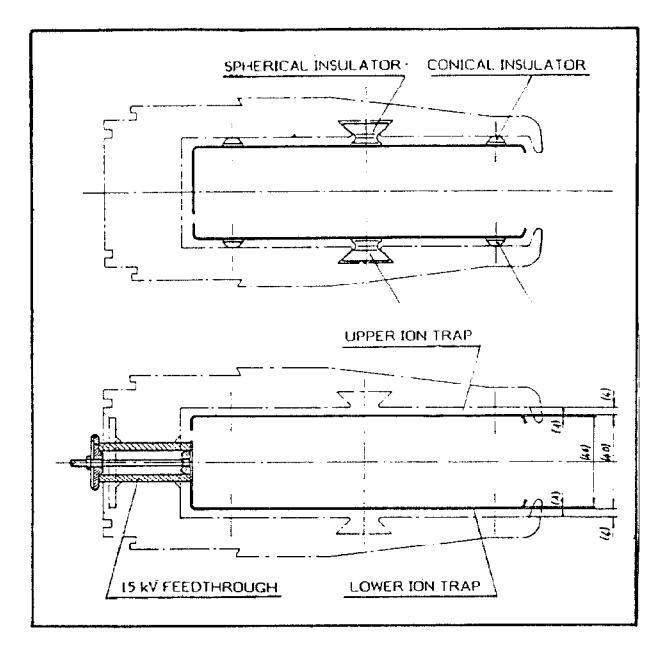
The sliding ion-traps are shown in Fig. 4. The spherical insulator centres the ion-trap and allows longitudinal expansion. The 15 kV-feedthroughs are made of one cylinder of alumina and at the same time

constitute the fixed points of the electrode system. In order to exploit the new possibilities of a thermally much more stable anode the septum wire diameter was reduced from 100 to 65  $\mu$ m. The effective

Fig. 4 Construction of the sliding ion-trap

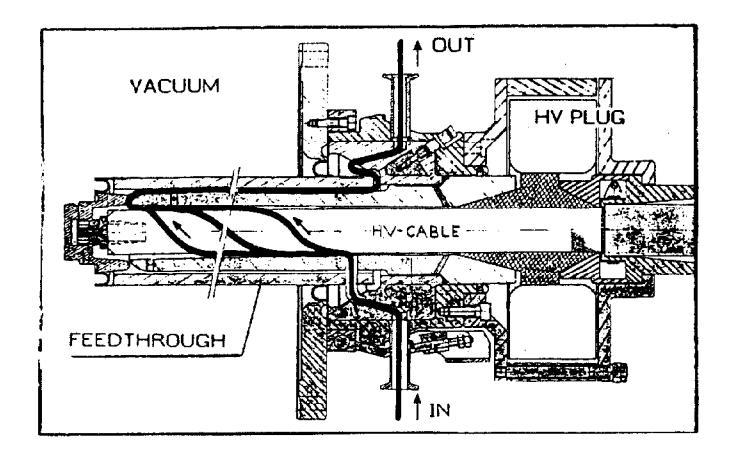
The feedthroughs have been improved by inversing the flow of the dielectric fluid as shown in Fig. 5 and by injecting this fluid into the cylindrical volume between cable and cable support. The cable end itself has been chamfered and the space between cable and support enlarged.

Fig. 5 The improved HV-feedthrough and HV-plug

In addition, some of the mechanical fixtures of the HV-plugs have been improved so that connecting and disconnecting can be done much faster which is crucial in a strong radioactive environment.

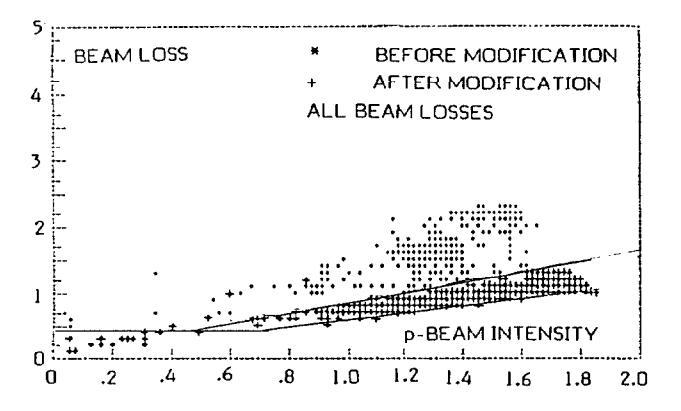
This is illustrated in Fig. 6 where all the beam losses which occurred during a run are plotted as a function of the p-beam intensity. The beam loss is not only reduced but also the spread has diminished considerably. This behaviour has been observed during all the subsequent runs showing that septum deformation mainly causes the spread and not machine or extraction parameter variations.

Fig. 6 The beam loss (arbitrary units) as function of the extracted beam intensity (x 1013) recorded before and after the modification.

Measurements made just before and immediately after the changeover show that the beam losses were reduced considerably.

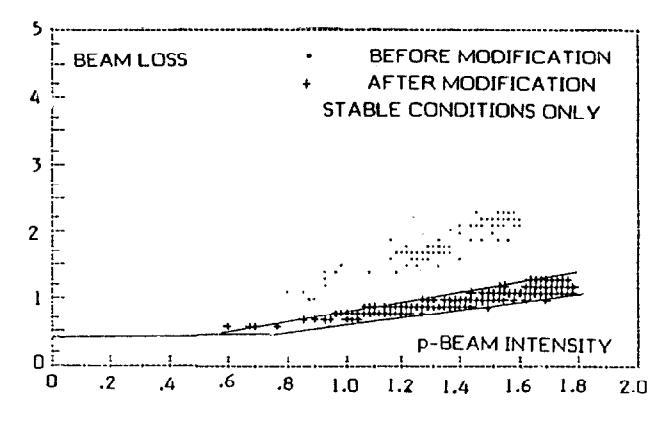
As shown in Fig. 7, reduced beam loss is even more visible if measurements are made after one hour of stable running with a resulting stabilization of the anode temperature.

Fig 7 The beam loss measured under very stable running conditions over a limited period of time.

- The beam loss has been reduced by a factor of 2 to 3.
- The effective septum thickness no longer changes with the anode temperature
- The beam loss rises linearly with p-intensity up to the highest values (2.5 \* 10<sup>13</sup> ppp) yet extracted by the SPS in one channel.
