SYNCHROTRON RADIATION EFFECTS AT LEP

R. Bailey, B. Balhan, C. Bovet, B. Goddard, N. Hilleret, J.M. Jimenez, R. Jung, M. Placidi, M. Tavlet, G. von Holtey, CERN, Geneva, Switzerland

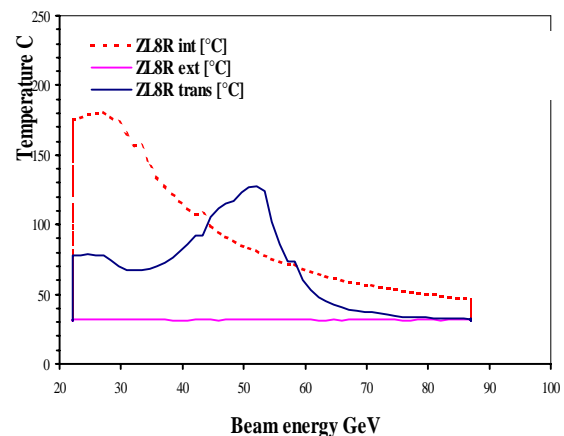
Repeated problems on transition sections of the vertical separators occurred near the wiggler magnets located in octant 7. Further investigations revealed that there were visible hot spots on the separator tanks themselves due to extreme local heating. Temperature probes were installed at various locations on the separators and transitions, which allowed the monitoring during the various modes of machine operations [4]. This allowed the source of the heating to be definitely identified as synchrotron radiation from the wiggler magnets. An example of the temperature variation on a vertical separator tank during the energy ramp is given in Figure 1.

Figure 1: Temperatures measured on the interior and exterior sections of a separator tank and associated transition cone. The different behaviour between the three probes is clearly seen.

Based on these results, wiggler magnets were moved to locations where they do not irradiate separators or transitions with significant power. In cases where this remedy is not possible, transition sections have been redesigned, with protected welds, water cooling and extra shielding installed. Measurements at the start of 1998 operation indicate that these precautions were adequate,

with no temperature increase measured on the separators or associated transitions.

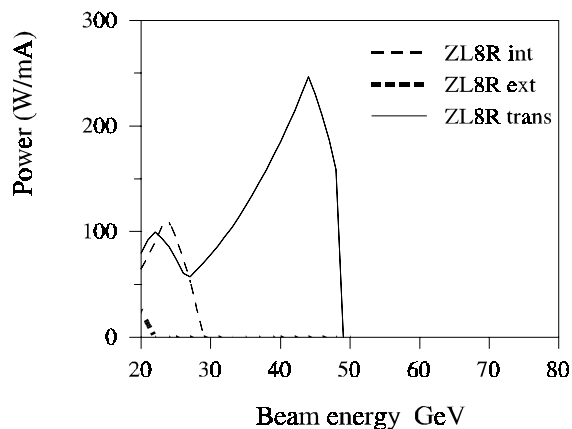
In order to calculate the power radiated onto the different parts of the separators and their associated transition cones, the angular acceptance of these parts seen from the different radiation sources has to be calculated as a function of wiggler fields and beam energy. This has been done [5] for equipment in octant 7, and the expected power deposition estimated. As shown in figure 2, this agrees qualitatively with the measured temperature profiles.

Figure 2: Calculated power radiated onto the interior and exterior sections of a separator tank and associated transition cones from three close by wigglers as function of beam energy.
