STUDIES OF BREAKDOWN IN HIGH GRADIENT X-BAND ACCELERATOR STRUCTURES USING ACOUSTIC EMISSION*

J. Frisch, J. Nelson, F. Le Pimpec, K. Jobe, D. McCormick, M. C. Ross, T. Smith, SLAC, Menlo Park, CA 94025 USA

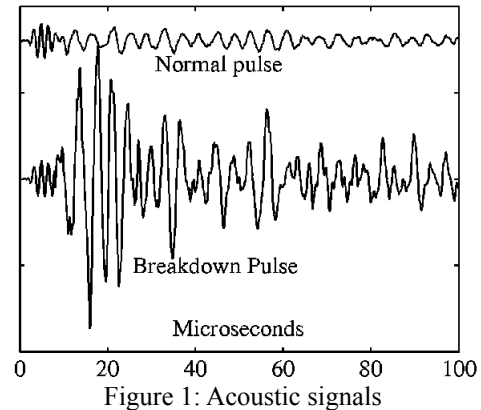
For both normal and breakdown pulses the acoustic signals have frequency content up to about 1 MHz. Figure 1 shows typical acoustic signals for normal and breakdown pulses. Note that the frequency response of the detector has not been subtracted from the data.

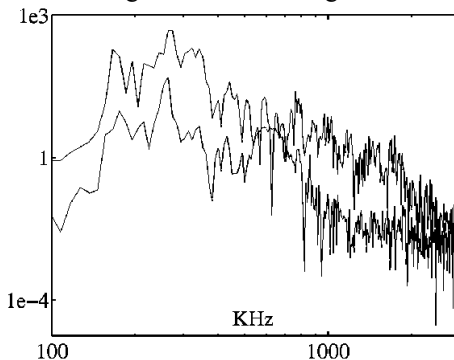
Figure 2: Power spectra for acoustic signals. Upper trace is breakdown pulse, lower is normal.

The acoustic spectra are fairly smooth, and drop at roughly 12dB/Octave above 300KHz. Note that the approximately 600KHz peak in the “normal” signal is believed to be due to electrical pickup from the modulator pulse. No correlation has been found between the energy deposited in a breakdown and the spectral content of the acoustic signals. However, by measuring the amplitude and arrival times at an array of acoustic sensors attached to the structure the location of breakdowns can be determined.

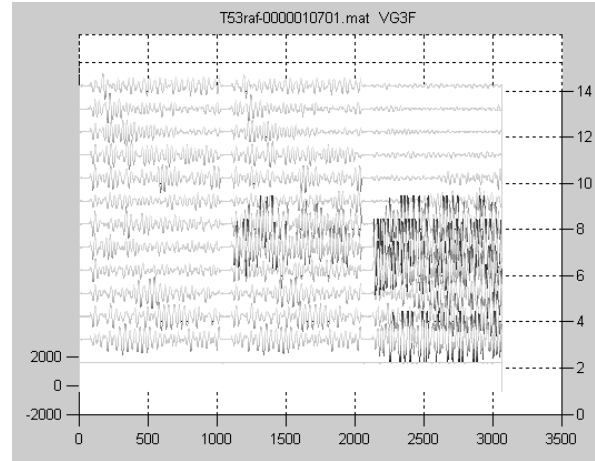
Figure 5: Sequence of 3 pulses

In this example, the RF was normal on the first pulse, and there was a small breakdown on the second pulse, which failed to trip the RF. On the third pulse there was a large breakdown. The front of the structure is on the bottom of the graph. Note that the timescale of the graph is compressed: the waveforms represent ~100us, with a 16 millisecond gap between the three waveforms.

For each breakdown, a series of waveforms similar to figure 5 is produced.

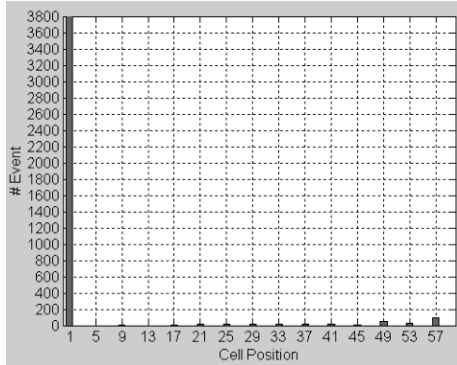
Figure 6 Breakdown locations in traveling wave structure

Measurements were conducted on a 60-cell traveling wave structure. The breakdowns occurred primarily in the input and output couplers, with a fairly even distribution

throughout the body of the structure (Figure 6). This matches the distribution deduced from RF data, although one to one matches of breakdowns were not done. [4]. Acoustic sensors have also been used to locate breakdowns in the Tesla Test Facility gun where the larger size of the RF structure produced very clean data [5].

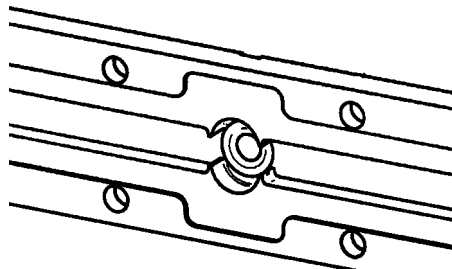
Figure 7: Input coupler. Note 4 “horns” on feeds.

The acoustic location system has proven very useful in diagnosing the high rate of breakdowns in the RF couplers. Figure 7 shows the input coupler, which has RF feeds from the sides. The 4 “horns” on the 2 RF feeds are located in a region of low electric field, but high magnetic field. An array of sensors was placed on the coupler to localize the RF breakdowns (Figure 8).

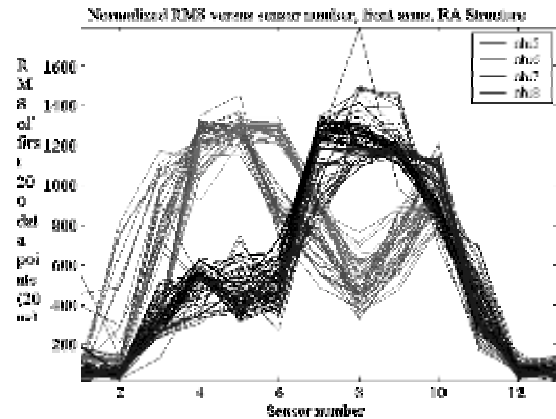
Figure 9: Coupler breakdowns occur in 4 types.

Data from a number of breakdowns was recorded and binned based on the ratios of power detected by the acoustic sensors in the first 20 microseconds of the pulse. The breakdown pulses were found to fall into 4 distinct types (figure 8). These were correlated with breakdowns occurring in the high magnetic field region on the coupler “horns”. Examination of the structure after operation found damage in the areas predicted by the acoustic measurements.
